WORK REPORT

FOUNDATION REPAIR
AND REGROUT
METALBOX BODYMAKER

CARNAUD METALBOX
SINGAPORE

Project: No 4 Bodymaker foundation repair & regROUT

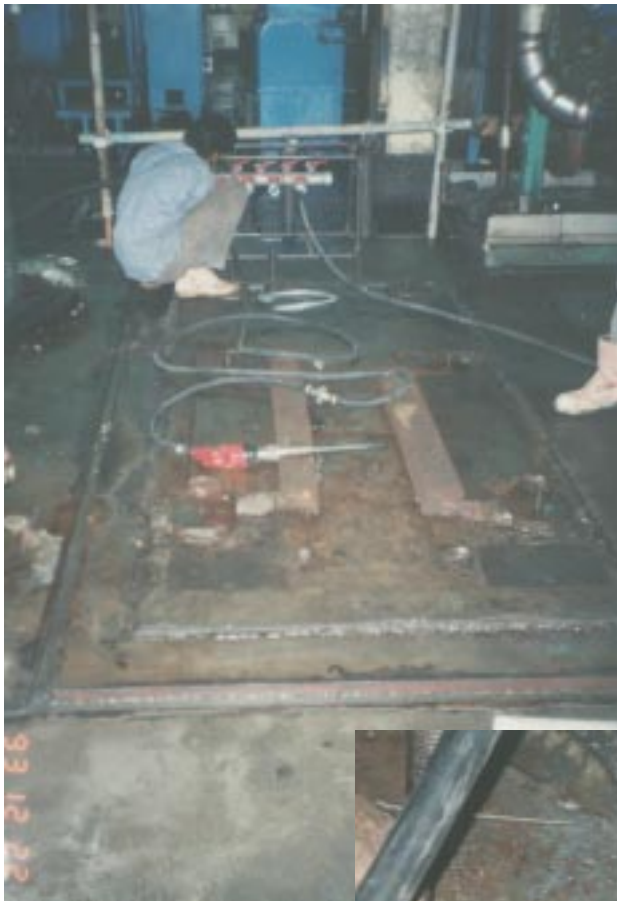
1.
93-12-22: Delivered materials and equipment to site, and started chipping out existing soleplates.

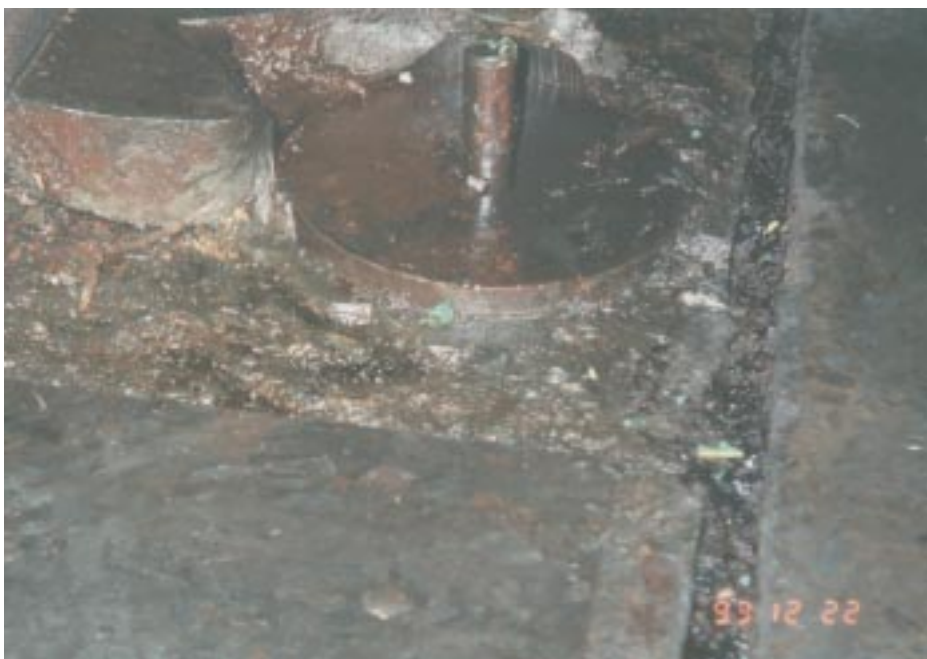
3.
The channel on the right hand side of the photo is the top of the vibration damping expansion joint..

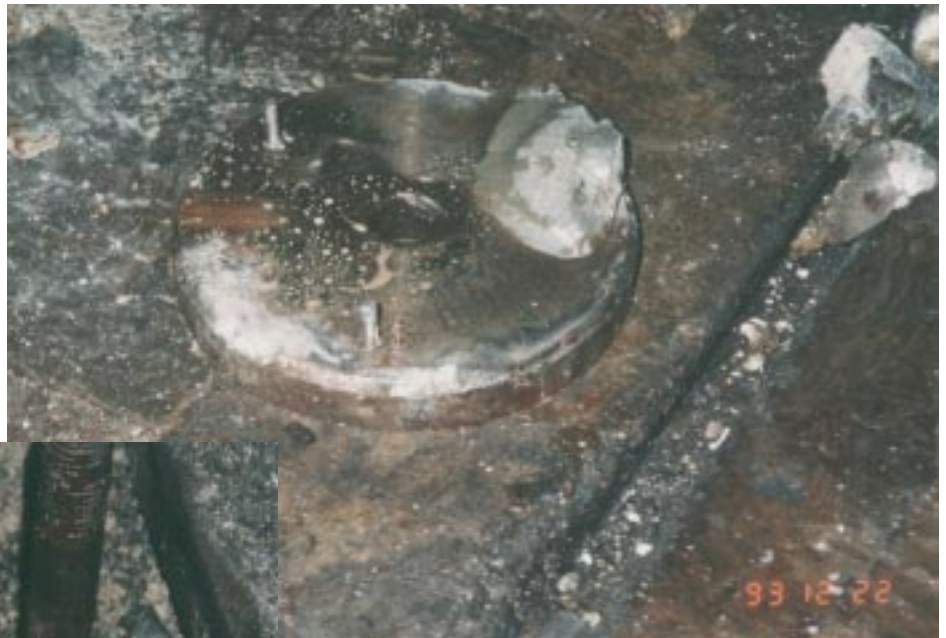
5.
The bond between the existing
soleplates and the grout was
very poor..

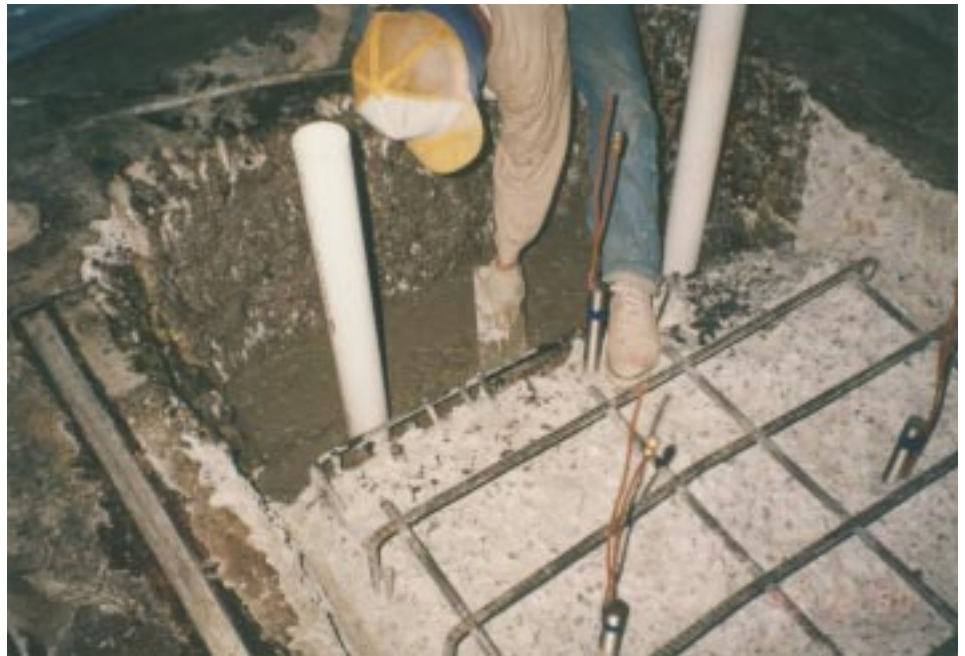
14.
...and the grout poured into the large excavation. The surface of the concrete had earlier been primed with epoxy resins.

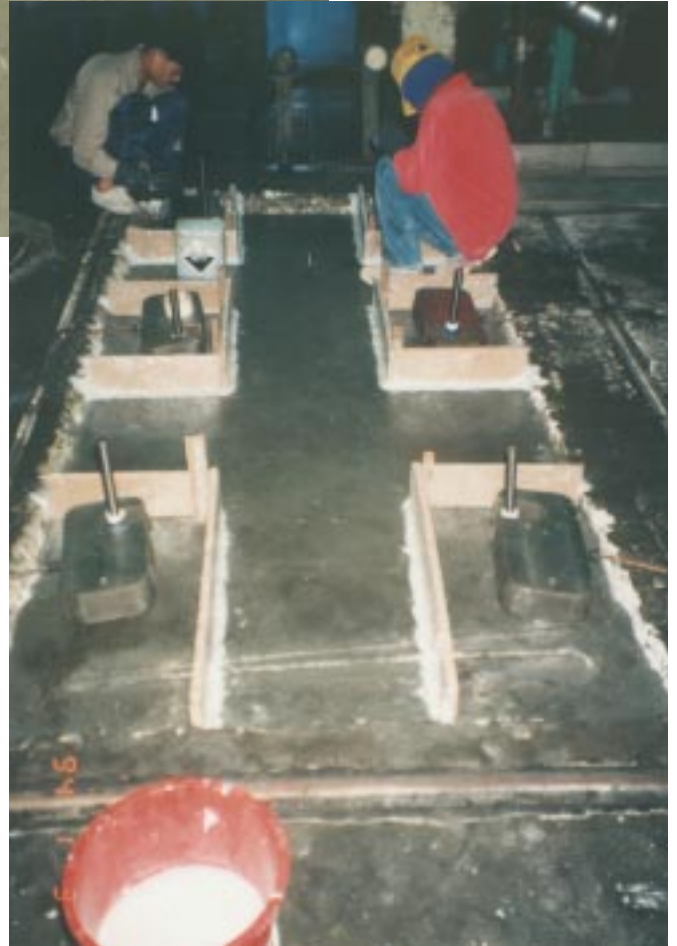
17.
Forms were set in place to contain the 2nd pour of epoxy grout, and the central area grout mixed and poured.
