# WORK REPORT

FOUNDATION REPAIR  
AND REGROUT  
METALBOX BODYMAKER

CARNAUD METALBOX  
SINGAPORE

**Project:** No 4 Bodymaker foundation repair & regROUT

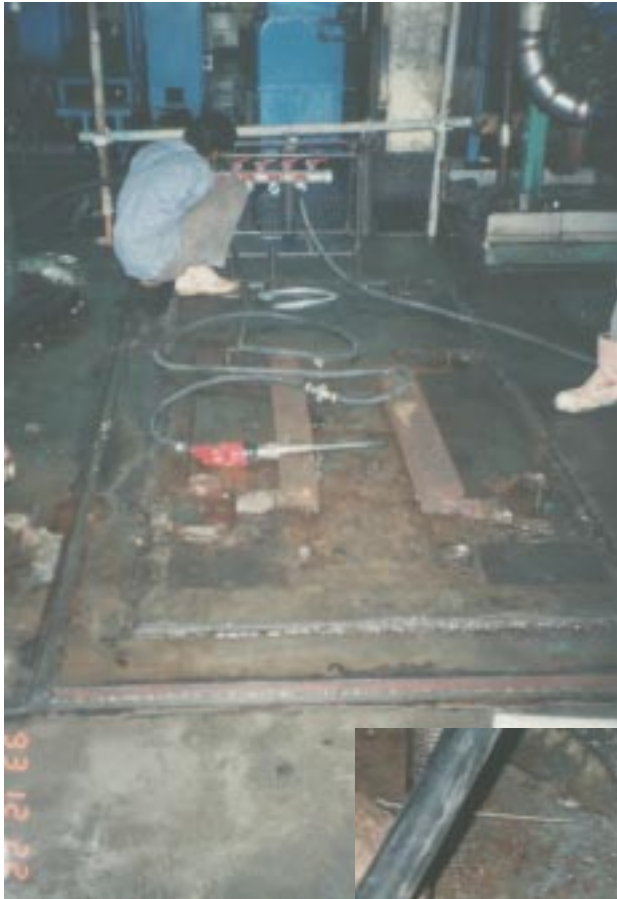
1.  
93-12-22: Delivered materials and equipment to site, and started chipping out existing soleplates.

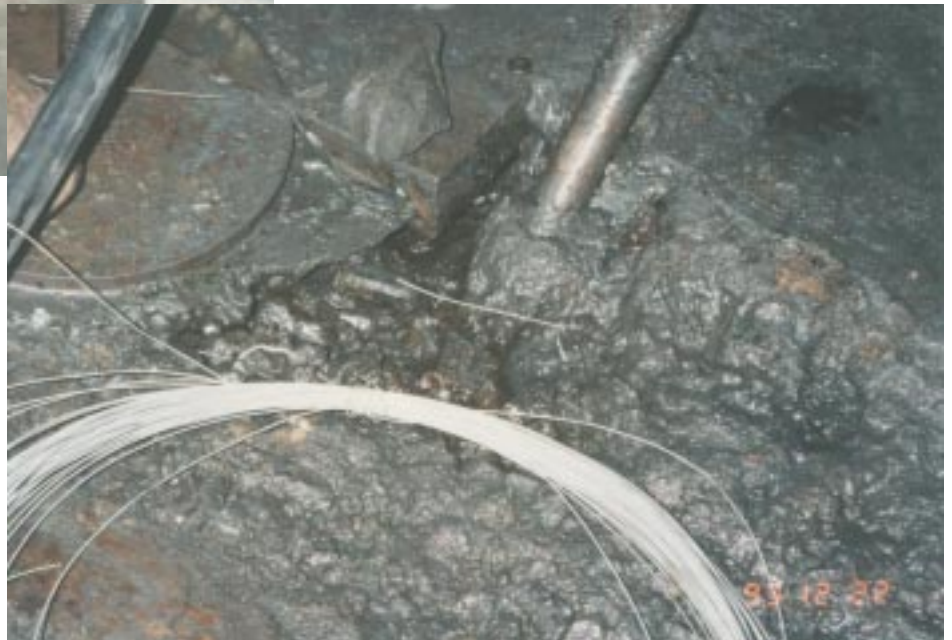
2.  
Heavily oil-soaked concrete.

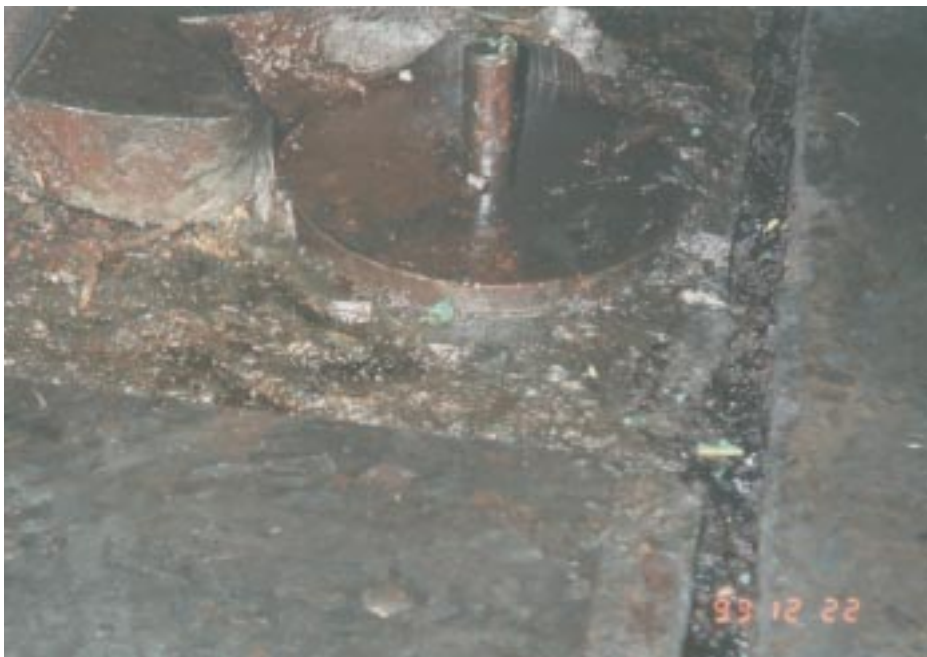
3.  
The channel on the right hand side of the photo is the top of the vibration damping expansion joint..

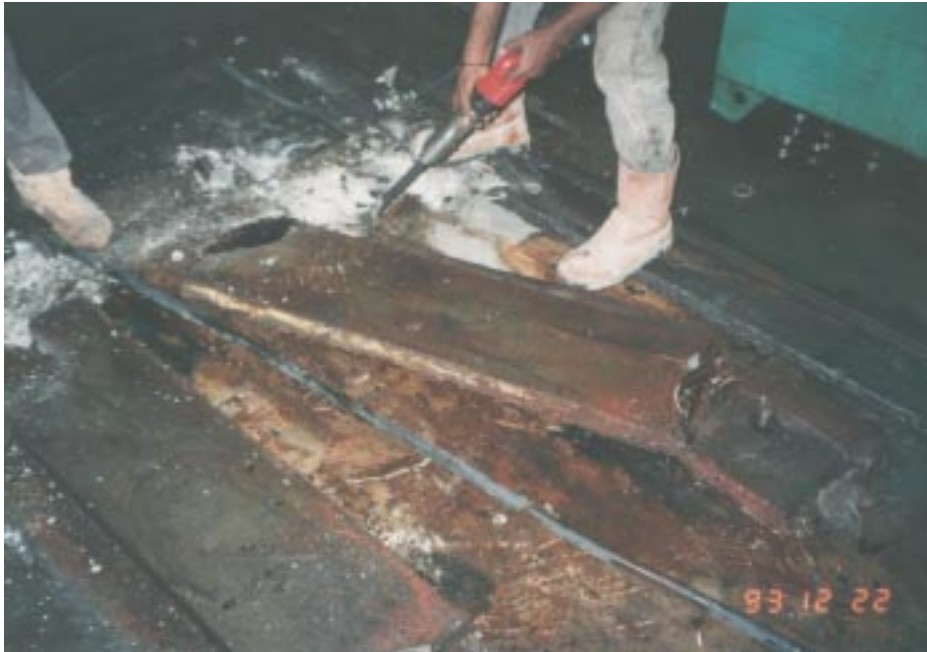
4.  
Chipping away the epoxy grout.

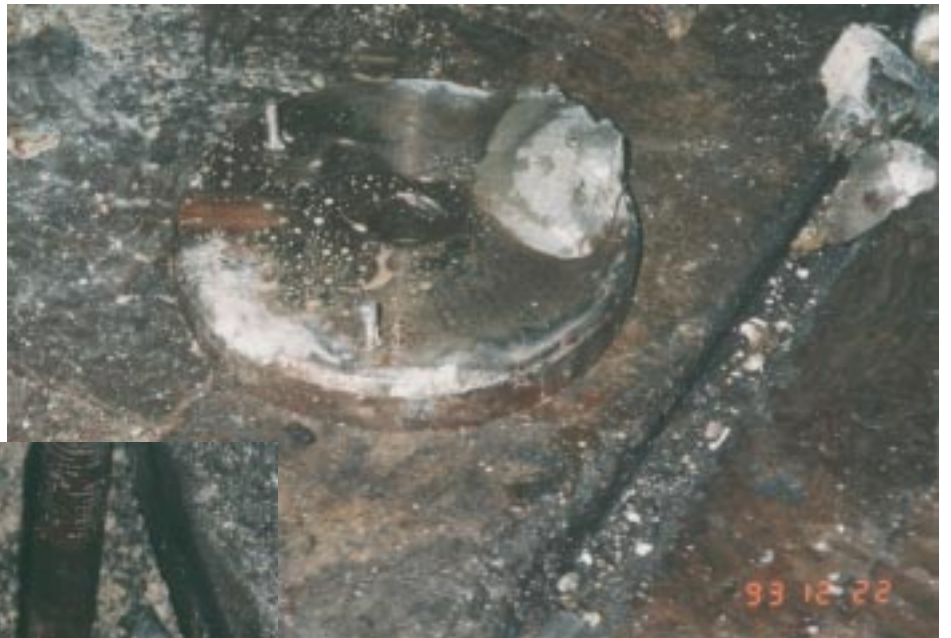
5.  
The bond between the existing  
soleplates and the grout was  
very poor..

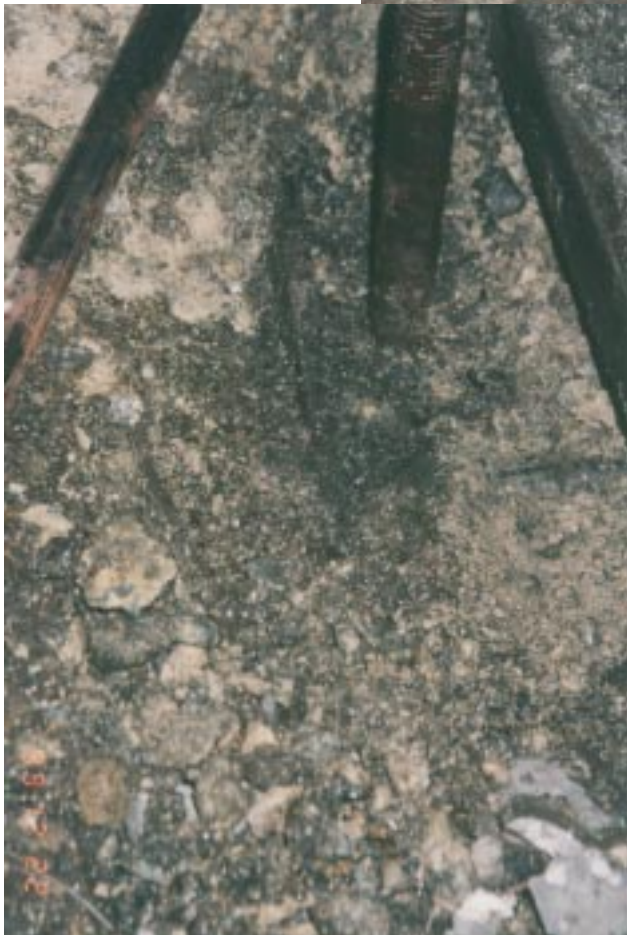
- 2.7 During the earlier repair of the foundation at the can feed end, a steel plate had been introduced, presumably with the intention of strengthening the whole structure. Unfortunately, the use of any additional steel within concrete in a machine foundation has the effect of weakening it, due to the increased number of interfaces between steel and concrete, the lack of bond at these interfaces, and the consequent ingress of oil. Oil degradation was found right down to 650 mm below floor level.

6.  
Chipping at the feed end revealed the embed-  
ded steel plate, and a lot of oil-soaked concrete.

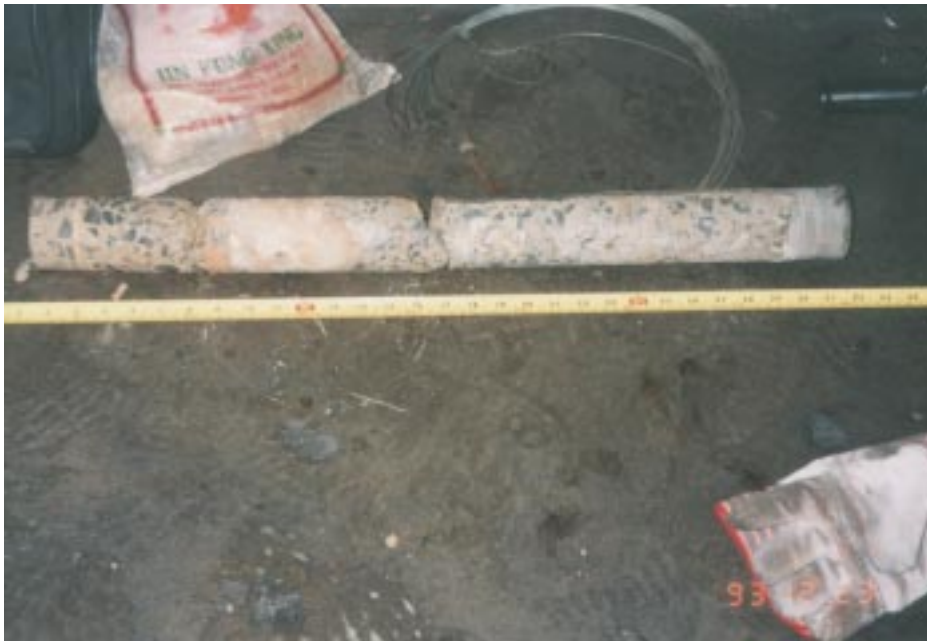
- 2.6 The depth of the inertia block proved to be approx 0.75 m, when the first cores were drilled, giving an effective mass of 6,372 kg. This is small for a reciprocating machine, which requires approximately 100 kg per kW to properly damp out the energy transmitted. In addition, there was no sign of any vibration damping pads under the inertia block, but instead a layer of clay-like material. Drilling was not continued below 750 mm, so the thickness, or even the existence of the support foundation, has not been confirmed.

7.  
93-12-23: The first core drilled revealed the thickness of the foundation, 750 mm, and the lack of vibration damping pads underneath. It also revealed the position of the cold joints.

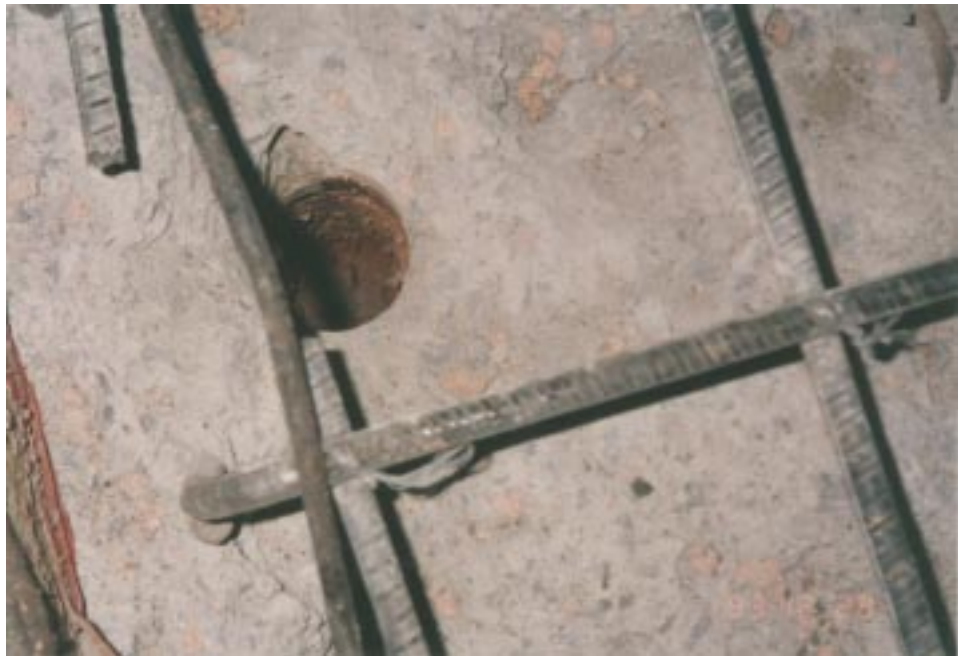
8.  
The cored holes were later used to position the new anchor bolts.

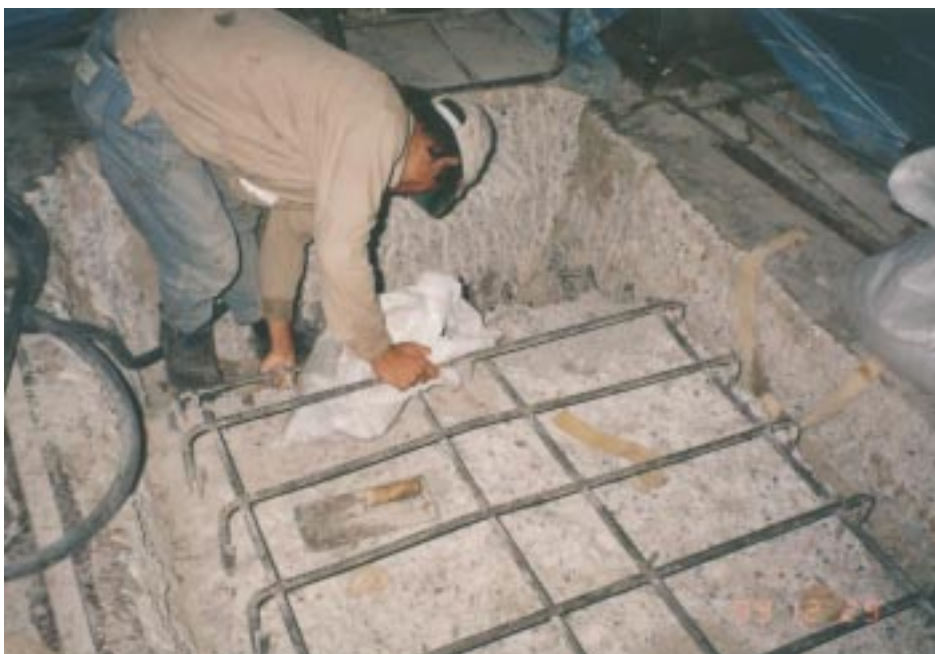
9.  
93-12-29: chipping finally completed.

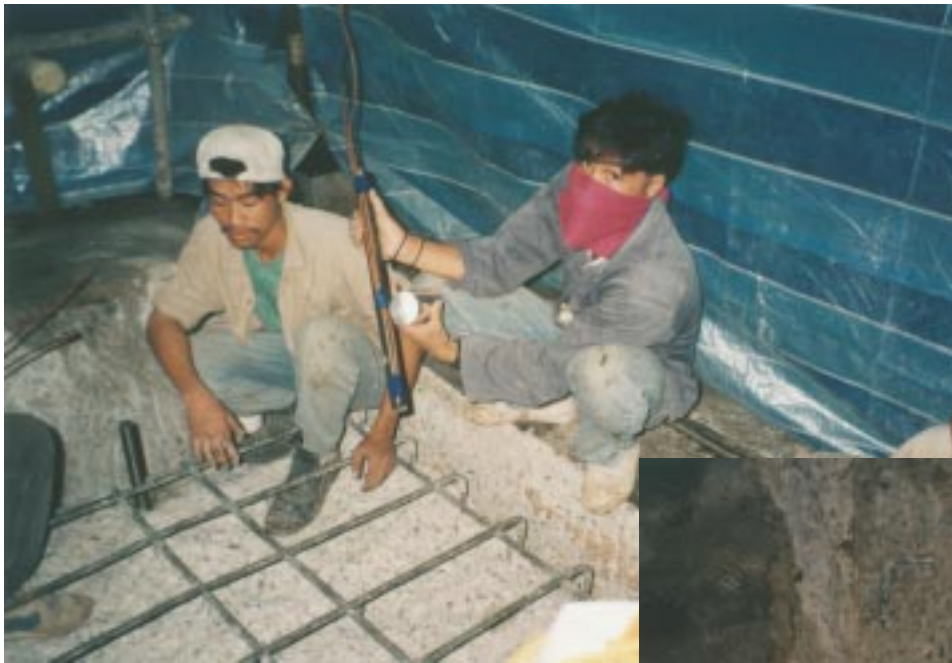
10.  
93-12-30: 32 mm  $\varnothing$  rods placed in the injection holes with injection and vent tubing attached.

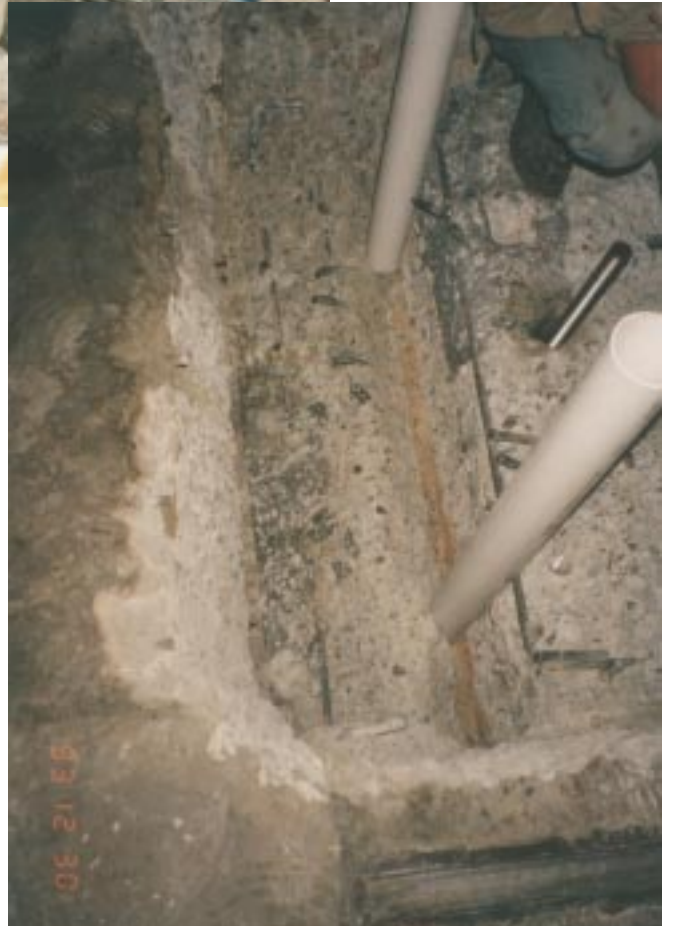
11.  
short lengths of PVC pipe were placed in position to re-establish the anchor bolt holes.

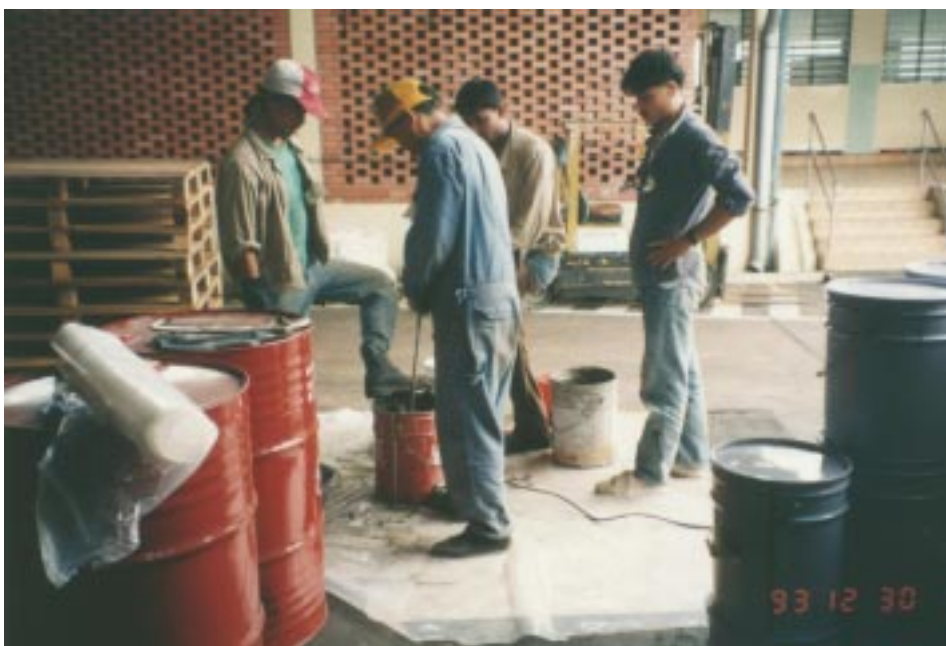
12.  
cement grout was mixed....

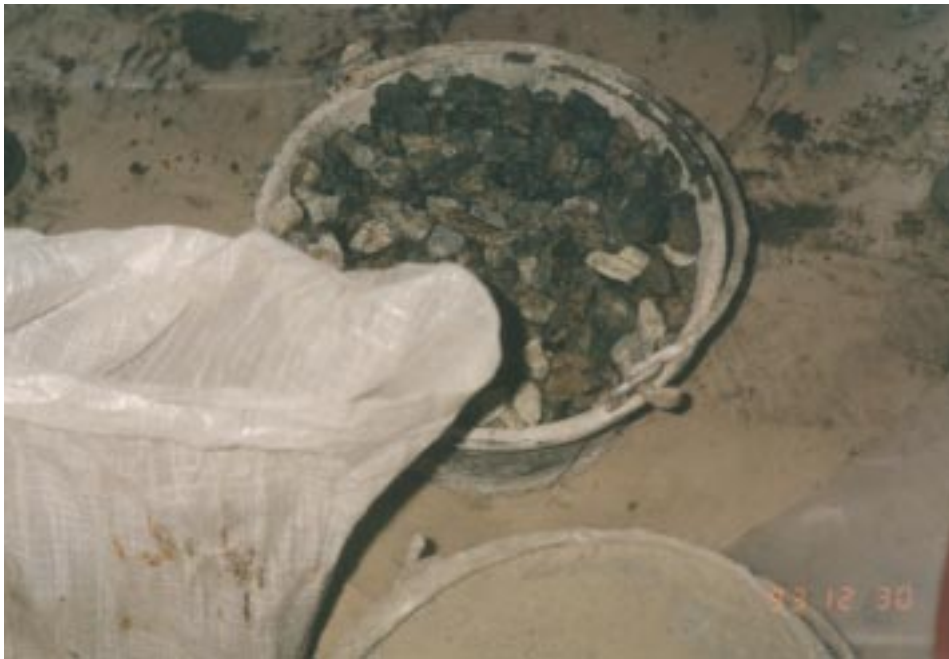
13.  
...crushed stone aggregate added...

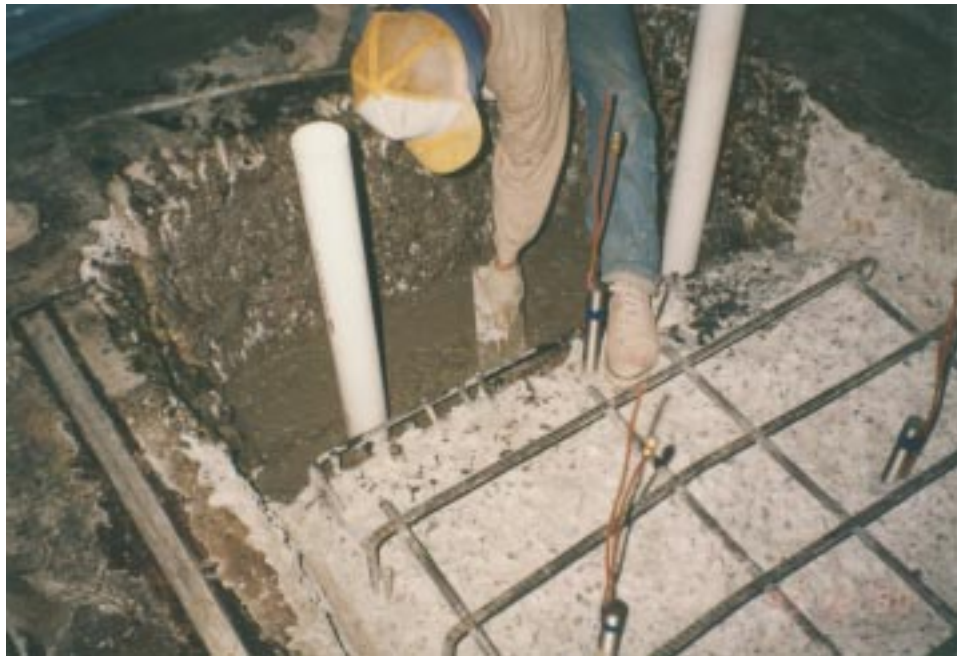
14.  
...and the grout poured into the large excavation. The surface of the concrete had earlier been primed with epoxy resins.

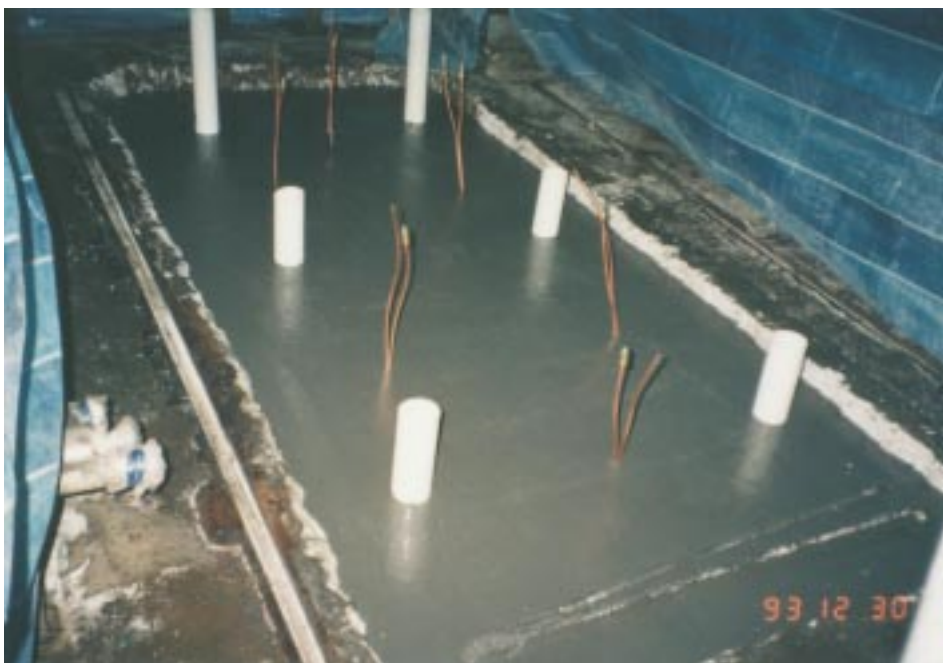
15.  
After the cement grout had set up, ALPHATEC 800 epoxy grout was mixed and poured overall to approx 60 mm below floor level. This pour also effectively sealed the injection holes, for pressure resistance of up to 300 bar. Injection was carried out on 31 December.

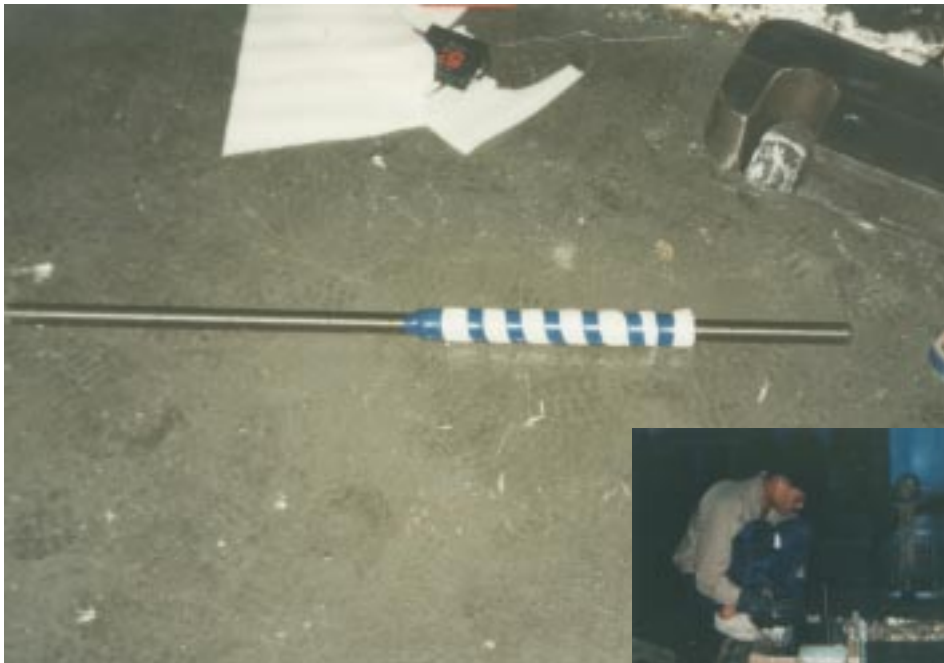
16.  
94-01-03: The new anchor bolts, fabricated from high-ten fully threaded rod, were prepared for installation, with 300 mm of isolating PE foam attached.

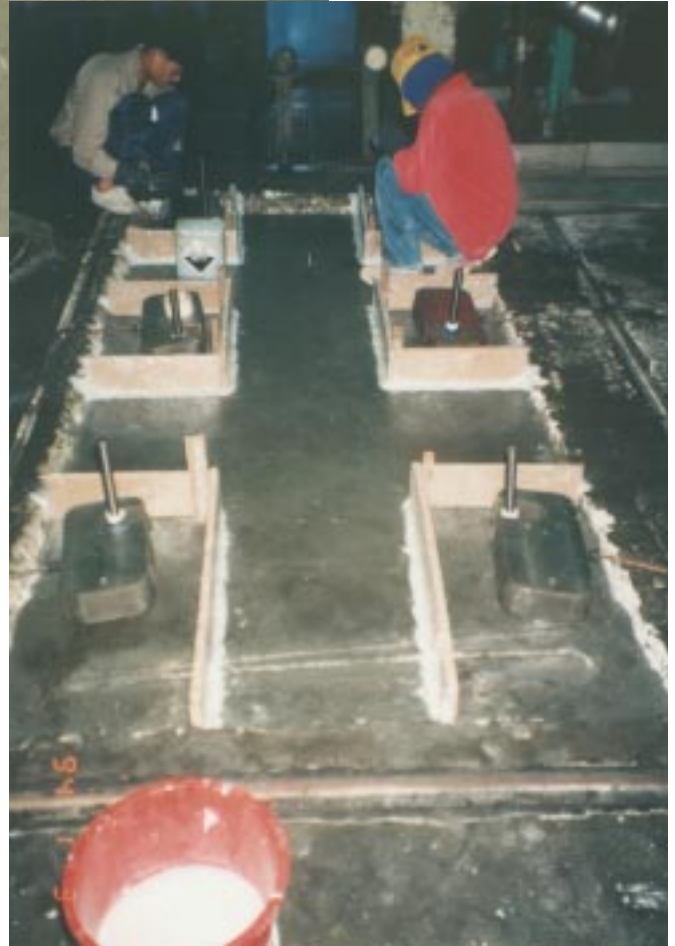
17.  
Forms were set in place to contain the 2nd pour of epoxy grout, and the central area grout mixed and poured.

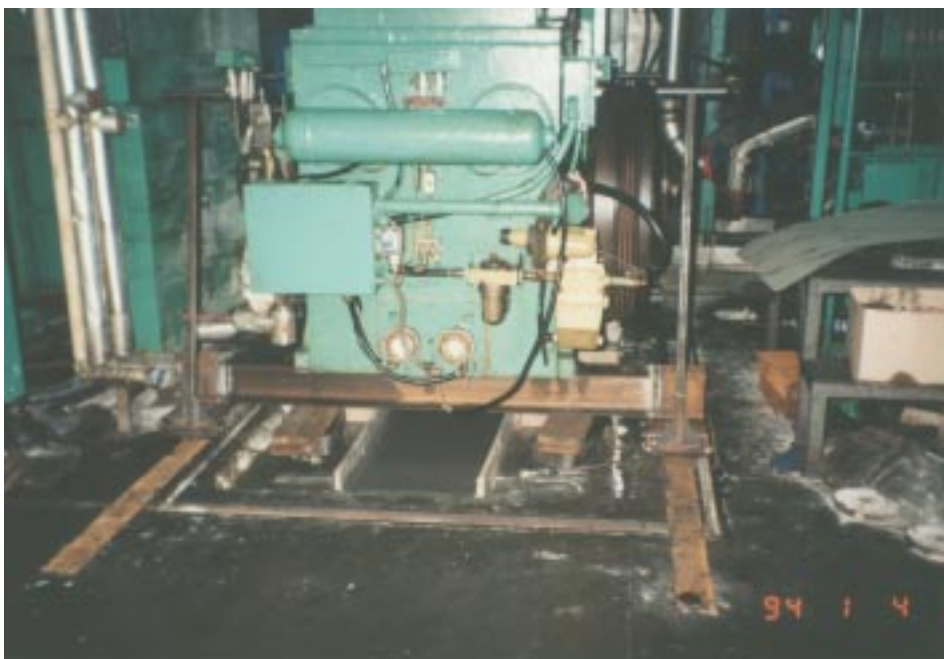
18.  
94-01-04: The bodymaker was transported back onto the foundation...

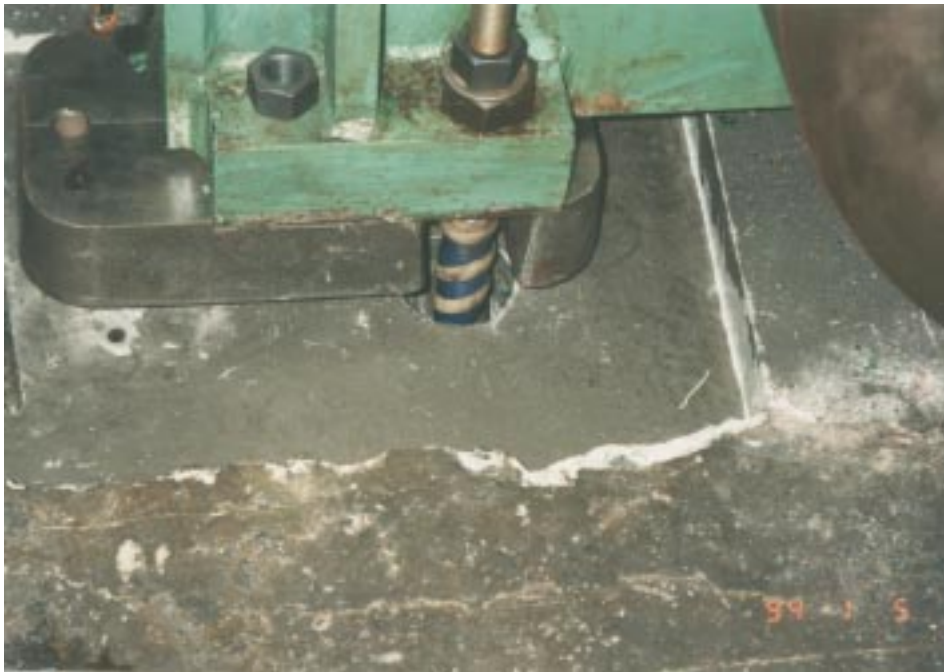
19.  
...and lowered onto the  
ALPHAPAD soleplates.

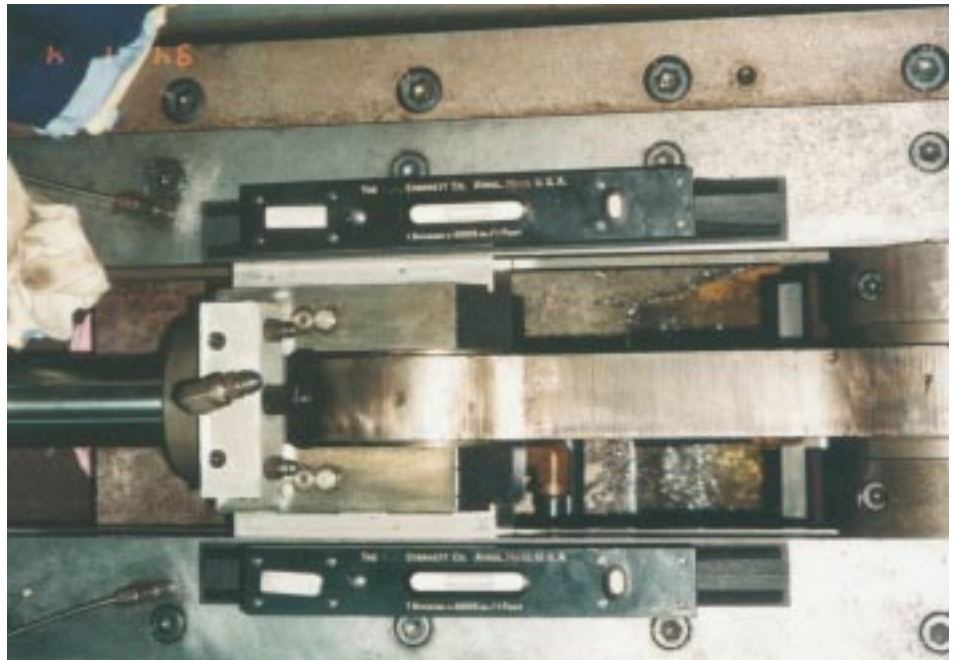
20.  
The bodymaker was lev-  
elled....

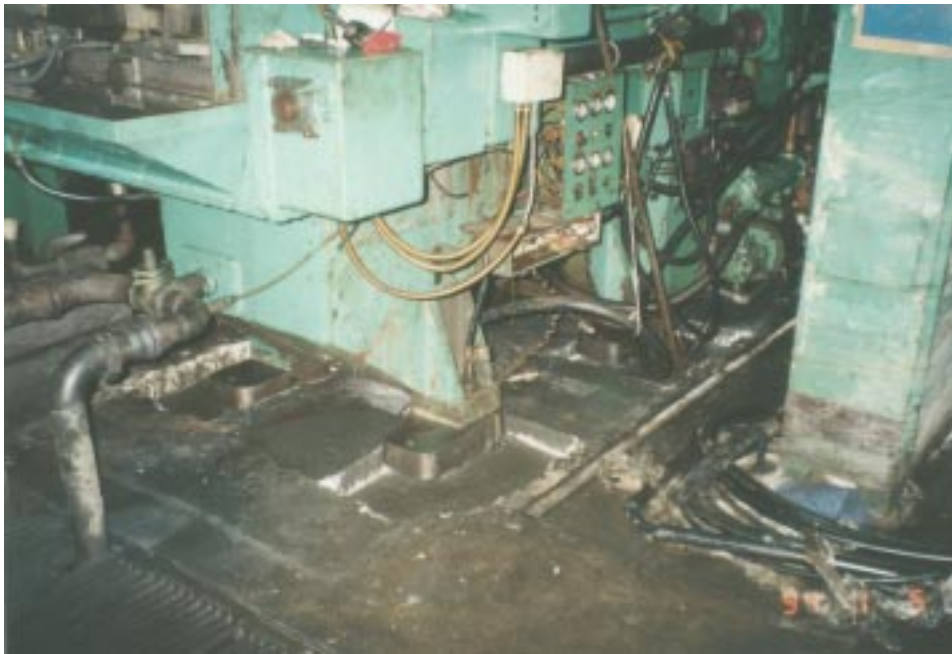
21.  
...and aligned with existing  
pipework, feed and output  
mechanisms.

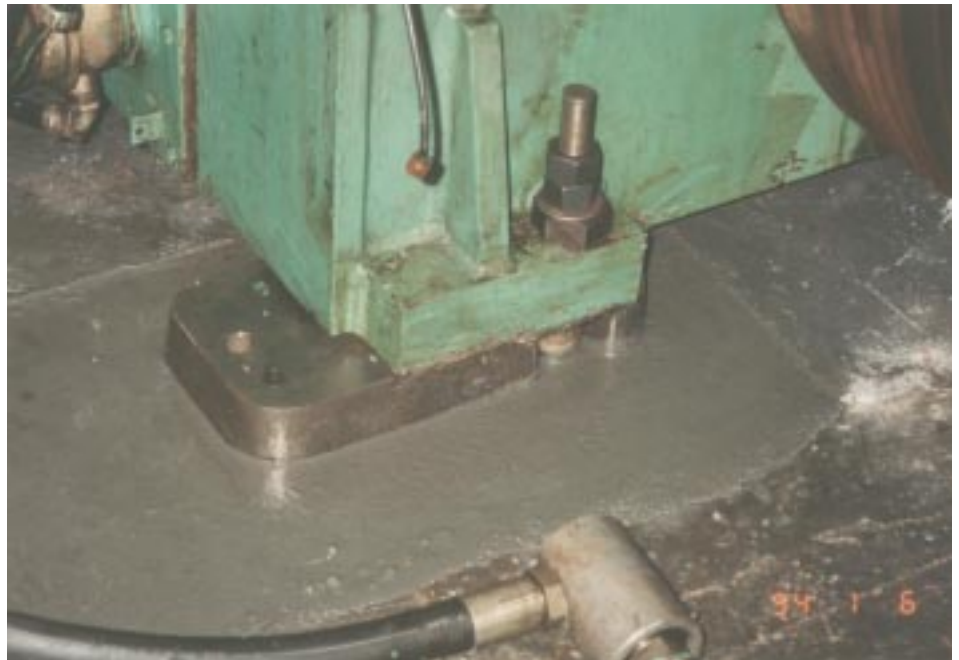
22.  
Epoxy grout was poured to  
embed the anchor bolts,  
and the ALPHAPAD  
soleplate.  
94-01-06: Finally the an-  
chor bolt nuts were torqued  
to 680 N.m, and the lock  
nuts tightened.
