# WORK REPORT

FOUNDATION REPAIR,  
RE-ALIGNMENT AND  
REGROUT  
K-6510 COMPRESSOR

COURONNAISE DE RAFFINAGE  
PETIT COURONNE REFINERY

**Equipment:** K-6510 Recycle Gas Compressor

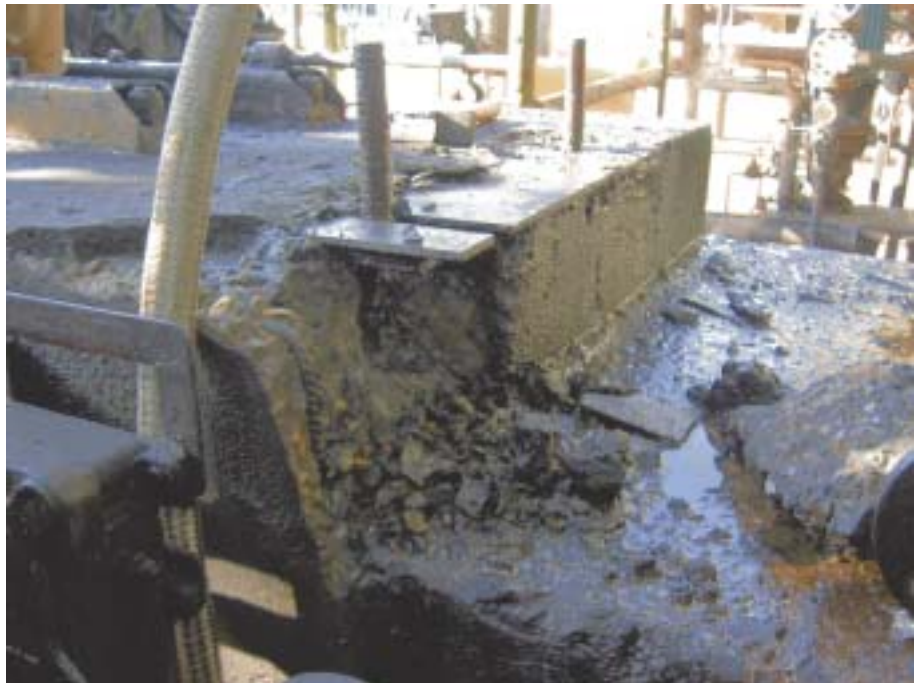
2.  
The compressor failure had been sufficiently violent to knock a piece of concrete out of place.

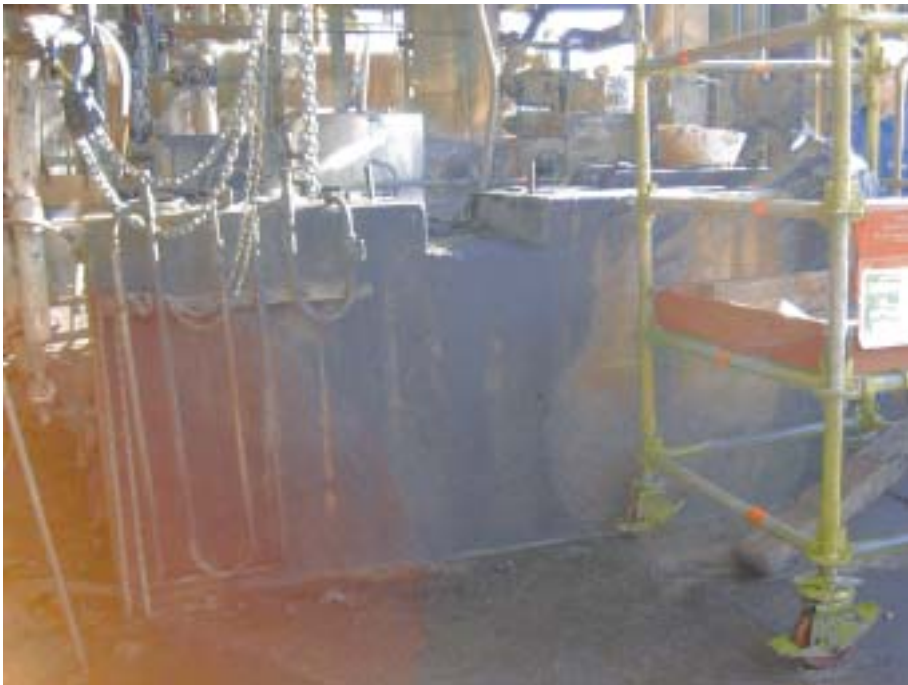
4.  
The foundation appeared to have been well constructed, with no obvious cold joints or separations.

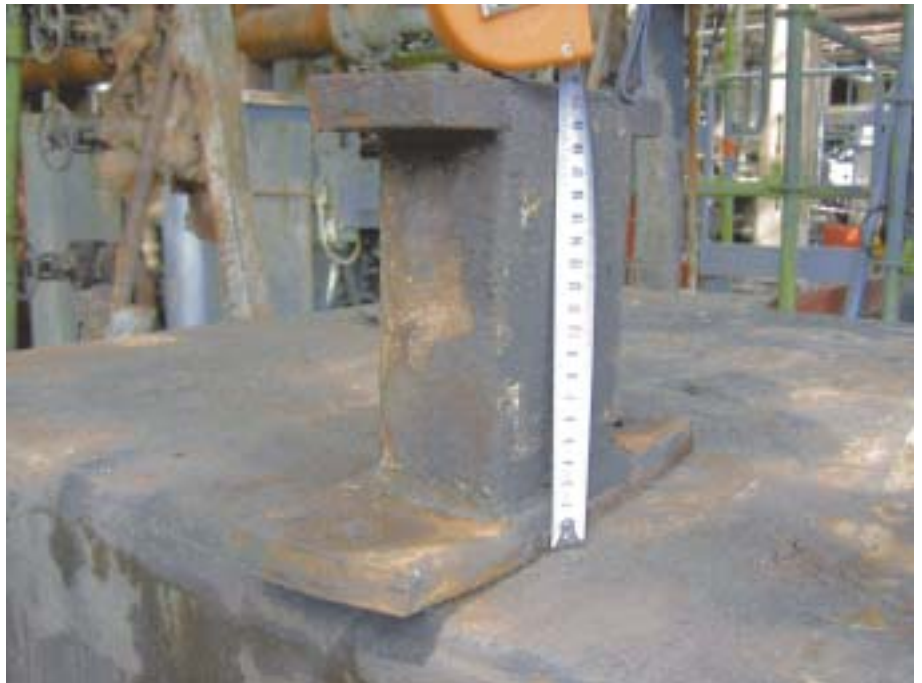
5.  
11 July 2005. Mobilization was rapid, and work started less than a week after the initial inspection. The first job was to check some critical dimensions.

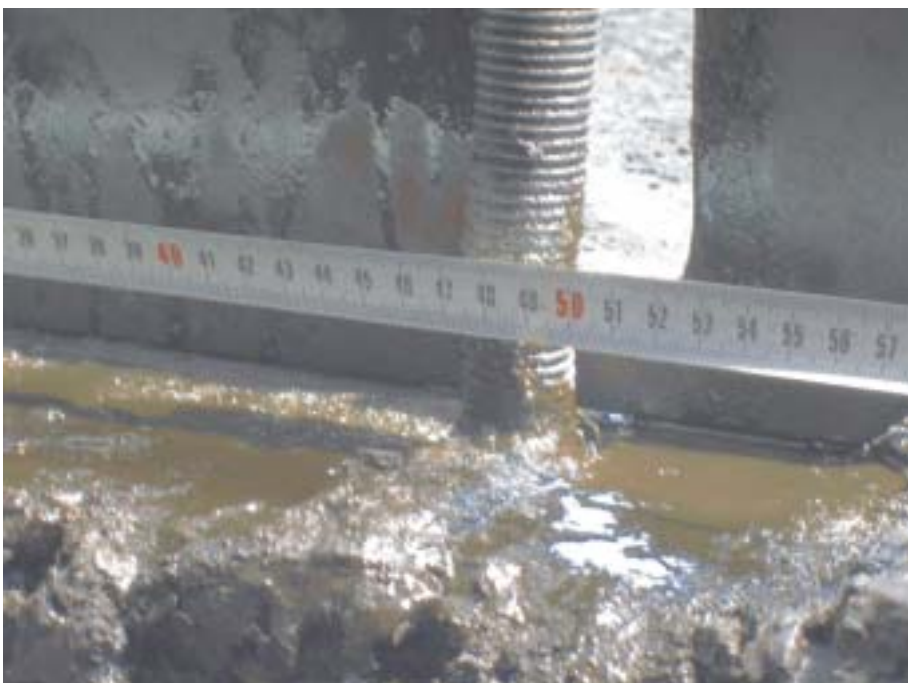
6.  
The centrelines of the anchor bolts, despite the distortions, appeared to correspond to the available drawings.

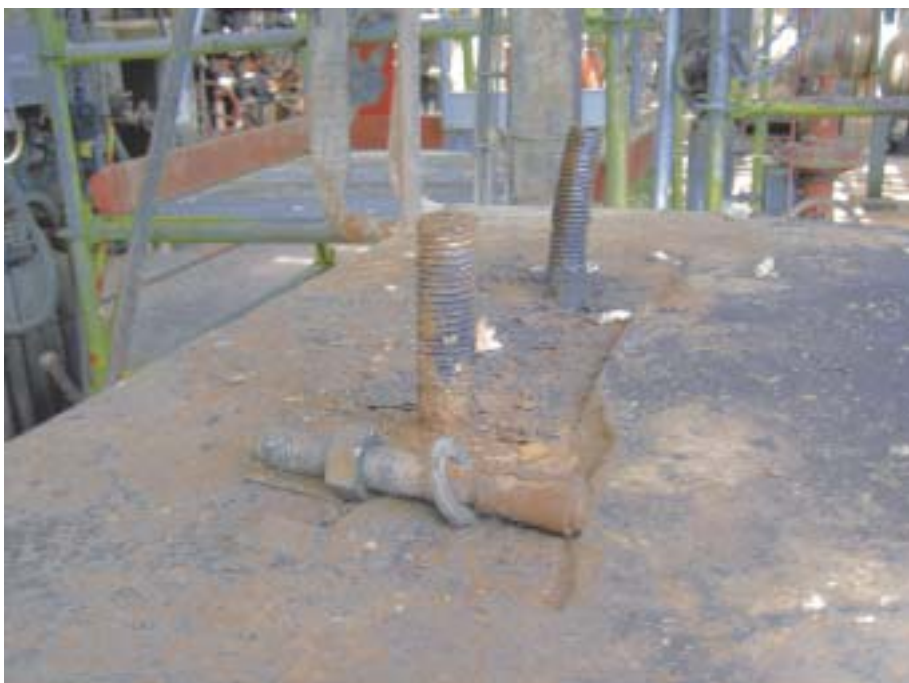
9.  
Since the crosshead support had been redesigned to use 4 anchor bolts, these damaged bolts could be simply cut off, and abandoned.

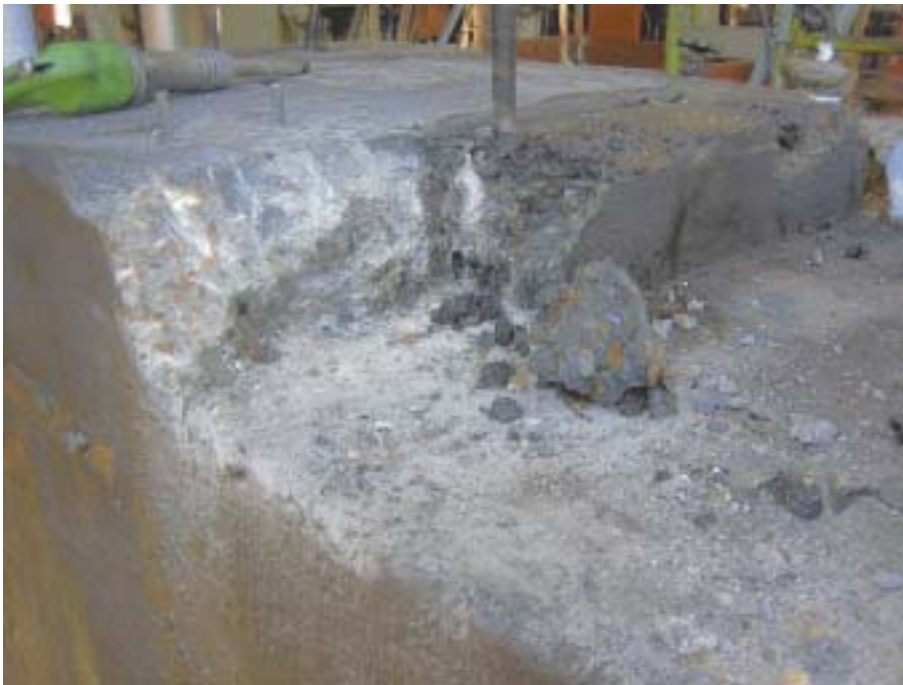
10.  
Chipping of the damaged grout and concrete started the first afternoon, and went quickly, due to the oil-soaked condition.

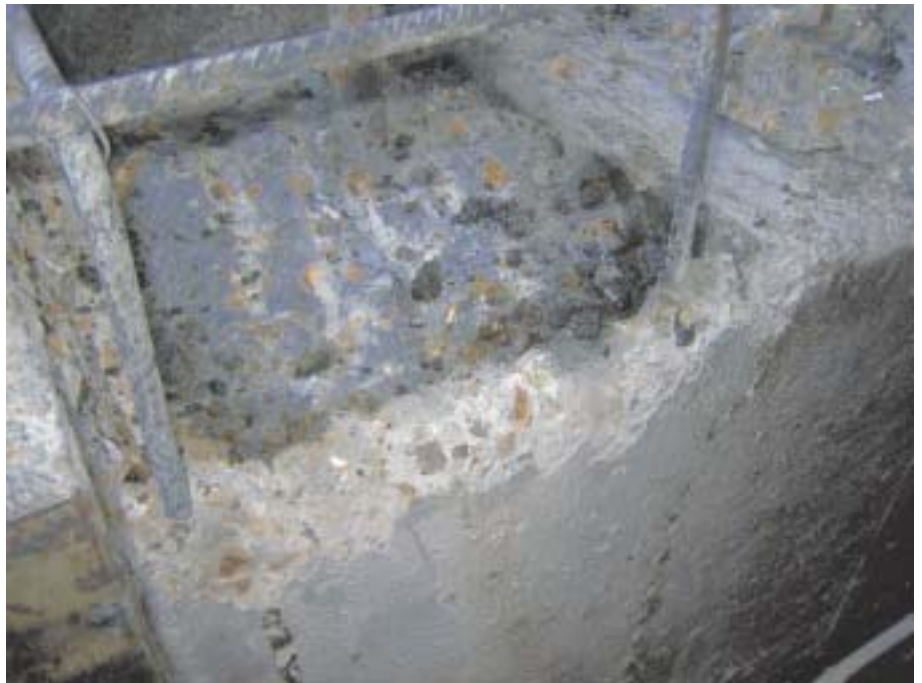
11.  
The blue-tinted cement which had been used for the anchor bolt grouting appeared to be a non-shrink grout mixed with aggregate - quite a good approach to the job, but the interface between grout and foundation concrete suffers badly from oil penetration.

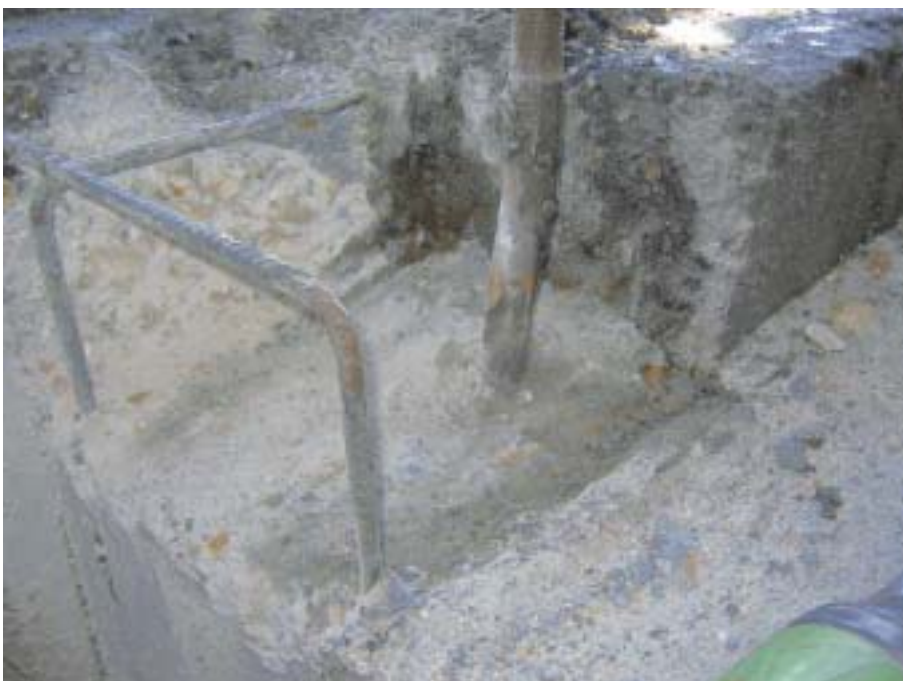
12.  
The amount of distortion of the crankcase anchor bolts was extraordinary.

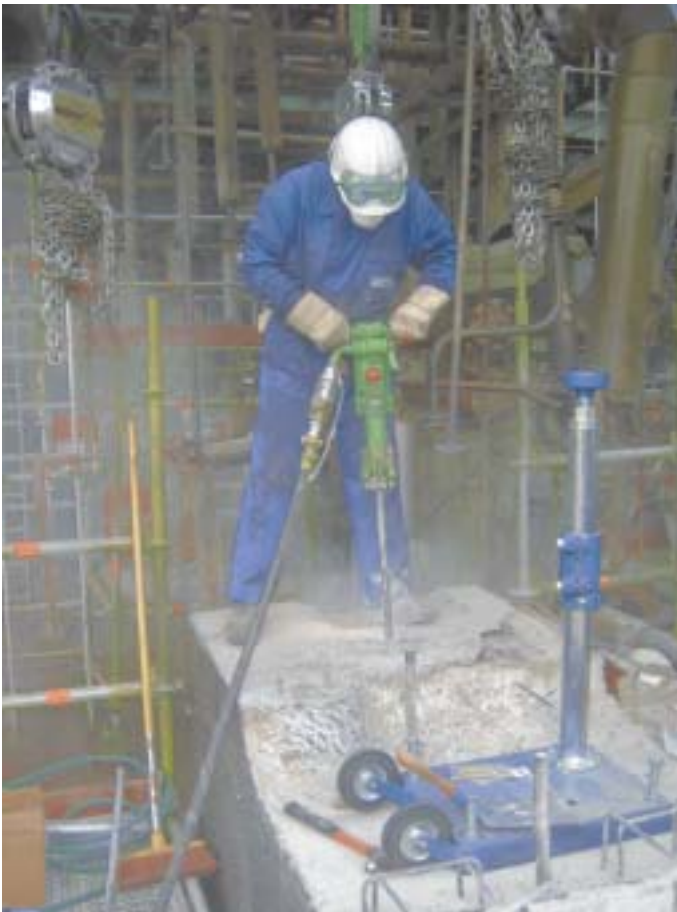
13.  
12 July 2005. A rotation-percussion rock drill was used to drill the new holes for the crosshead support anchor bolts, while the coring machine was being set up.

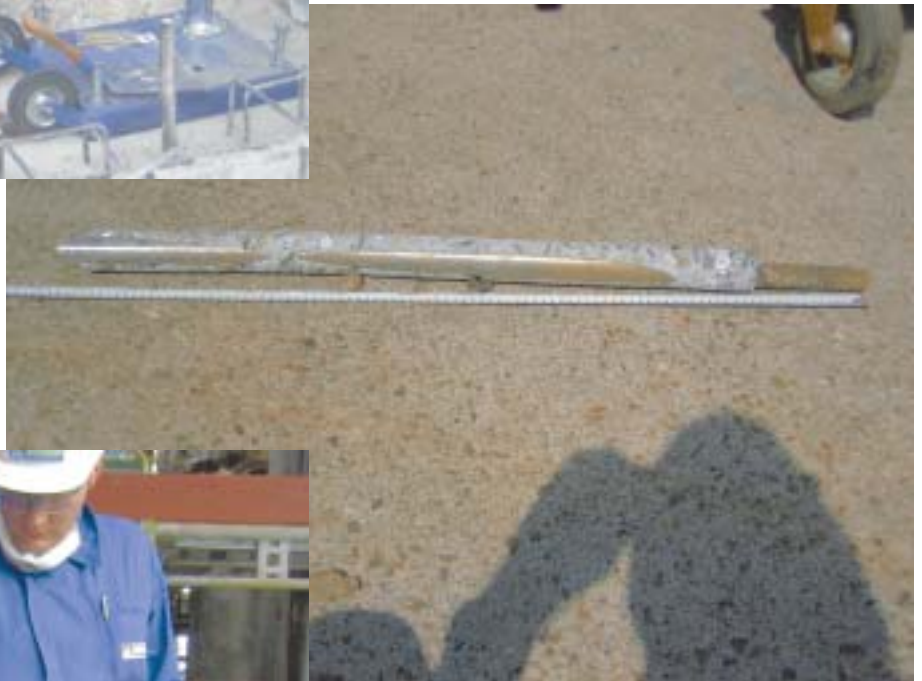
14.  
Cores were drilled to 1000 mm from the foundation surface to ensure full removal of the existing bolts.

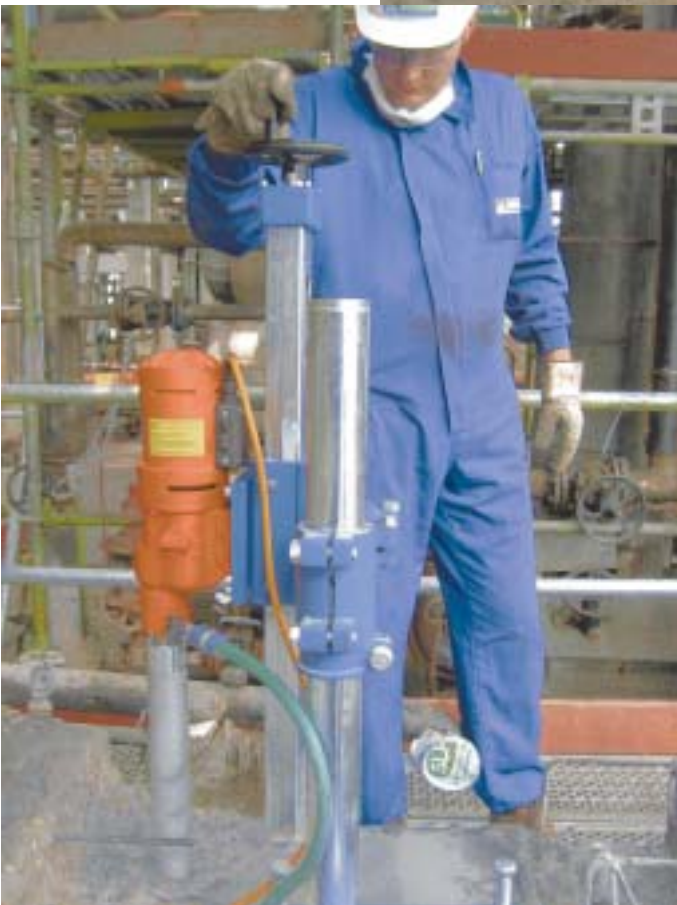
15.  
Diamond core drilling is a tedious business that continued throughout the week, in order to complete the removal of 10 anchor bolts.

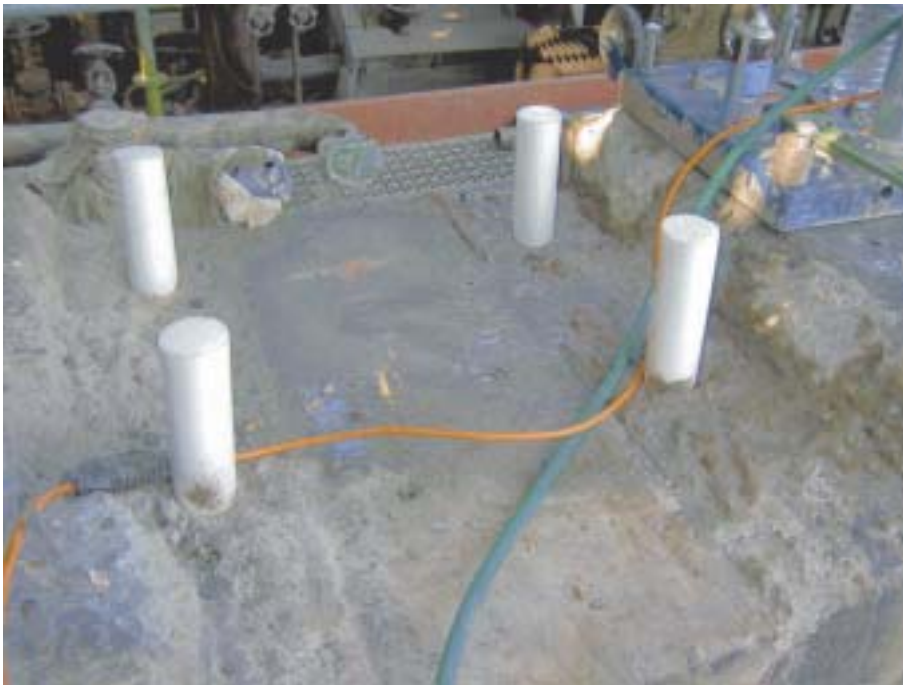
16.  
15 July 2005. Chipping and coring complete. The PE plugs have been pushed into the tops of the holes to prevent the first pour grout entering.

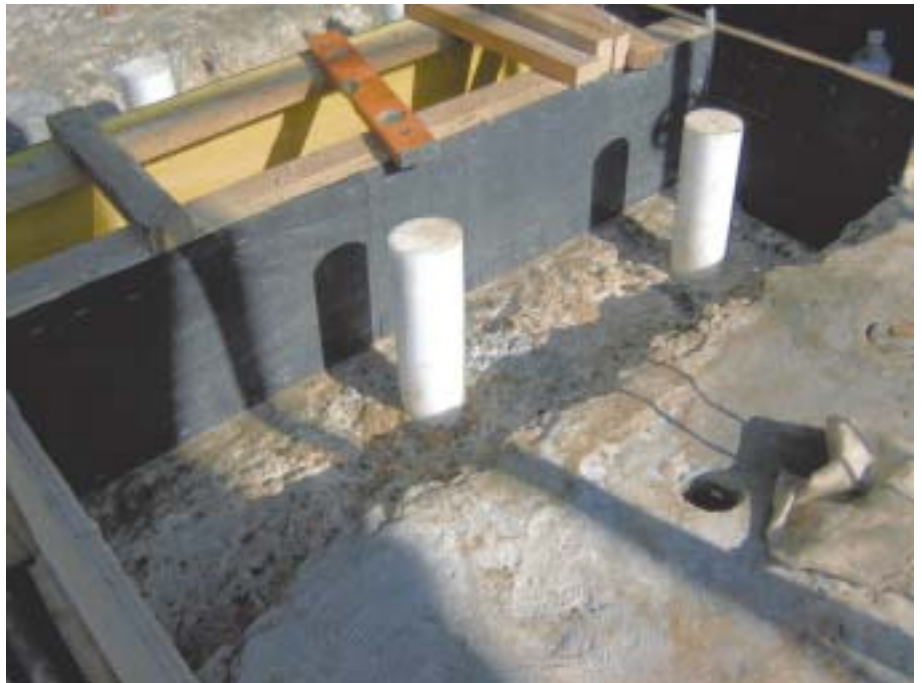
17.  
Formwork set in place, with a polypropylene liner stapled to the inside of the plywood as a release barrier.

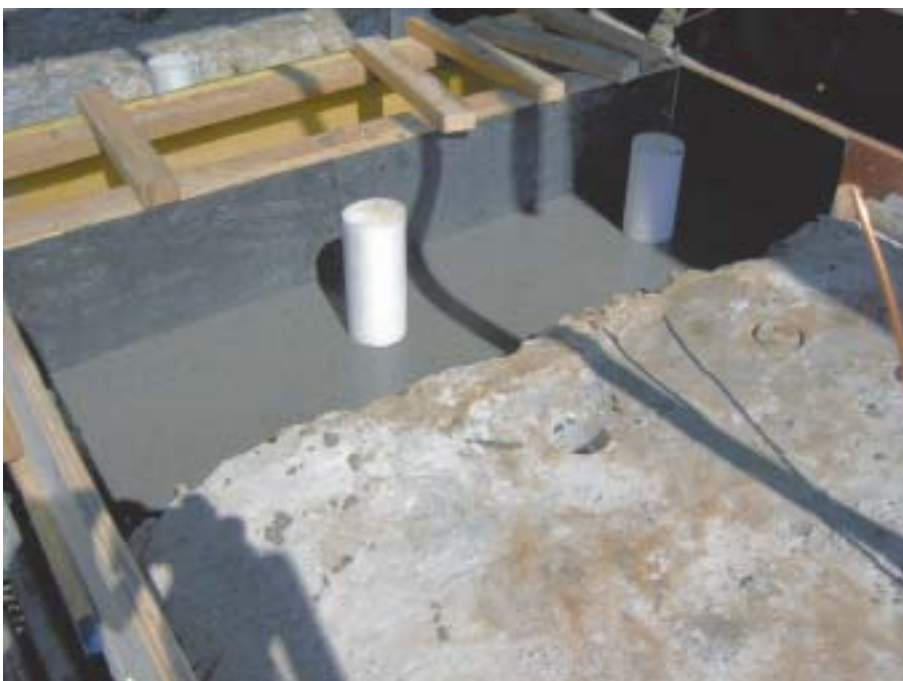
18.  
17 July 2005. ALPHATEC 800 epoxy grout poured to give a working level for installation of the soleplates.

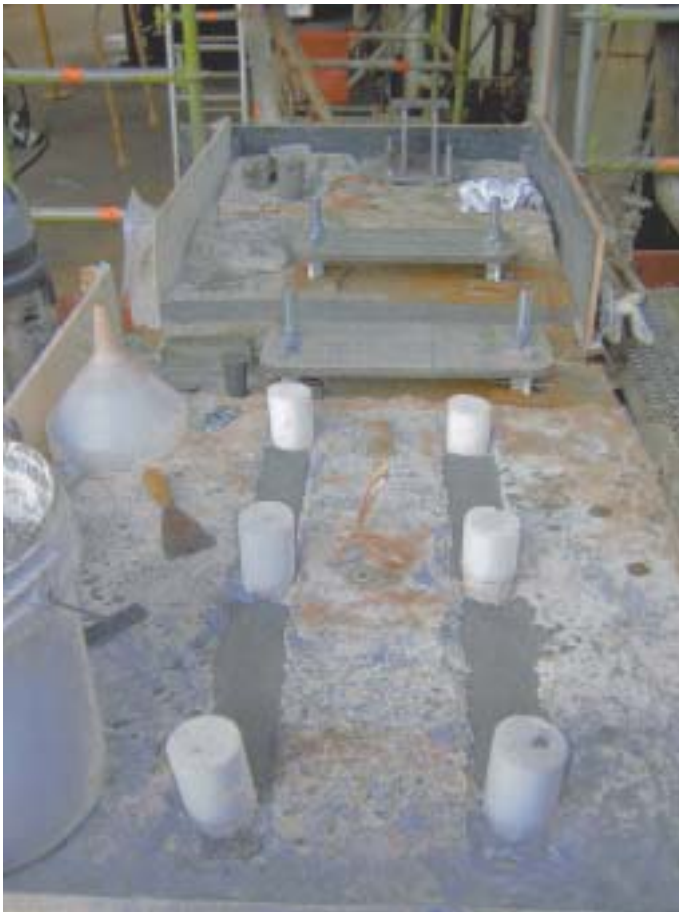
19.  
19 July 2005. All motor base bolts were finally removed, & the concrete under the bases chipped out and grouted for ease of re-installation. Note the copper tubing in the centre of the motor foundation. These tubes are set into a 1.5 m deep hole drilled into the foundation to ensure that the mass of concrete above the base of the anchor bolts is properly bonded to the mass below. Another hole is seen in the centre of the compressor plinth.

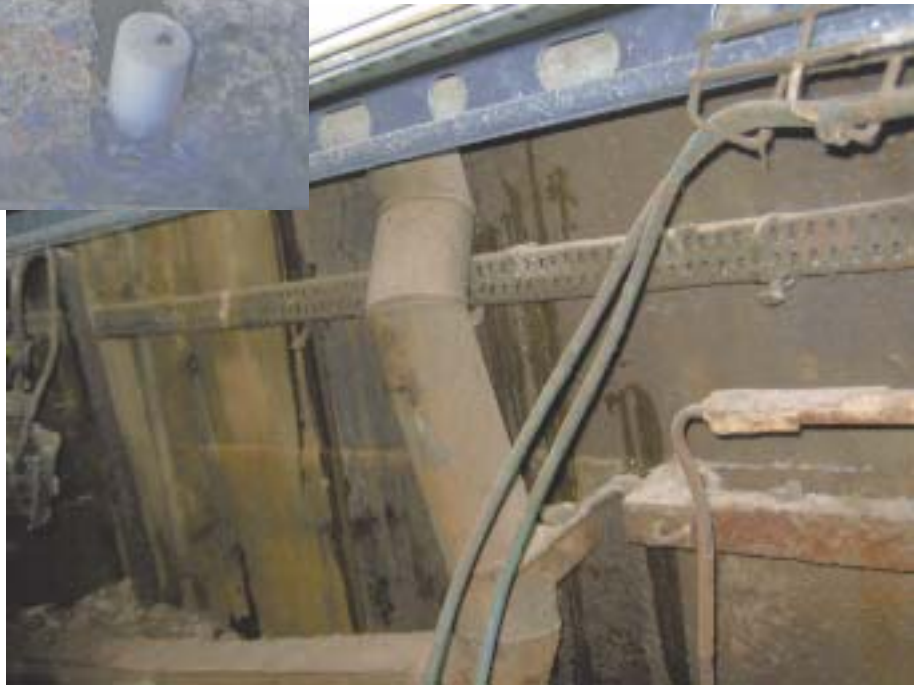
20.  
20 July 2005. During injection of the ALPHATEC 370 resins into these injection holes, some resin outflow was seen on the foundation side, indicating good coverage.

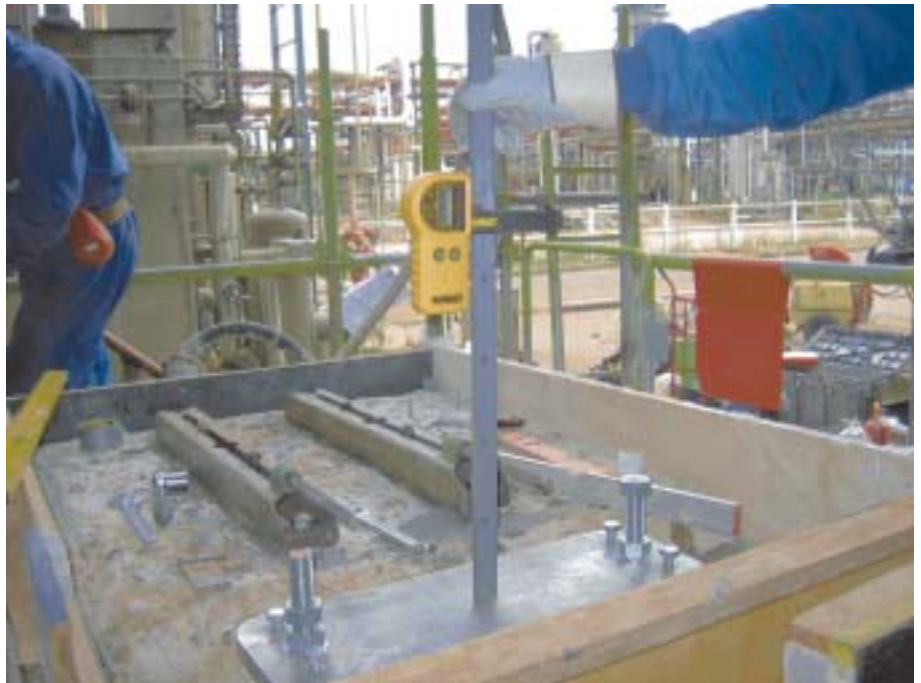
23.  
The soleplates were set up at an appropriate height using the laser level, and then levelled and aligned accurately by precision spirit levels, and other measuring devices.

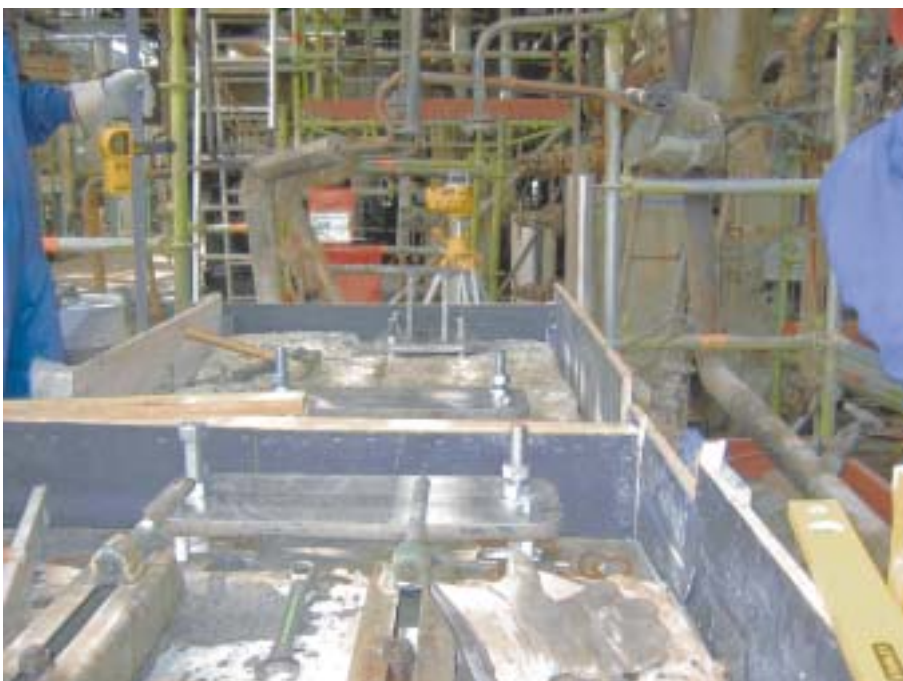
24.  
Once the position of all the bases was fixed with reference to the centreline, and to one another, the formwork was reset for the main grout pour.

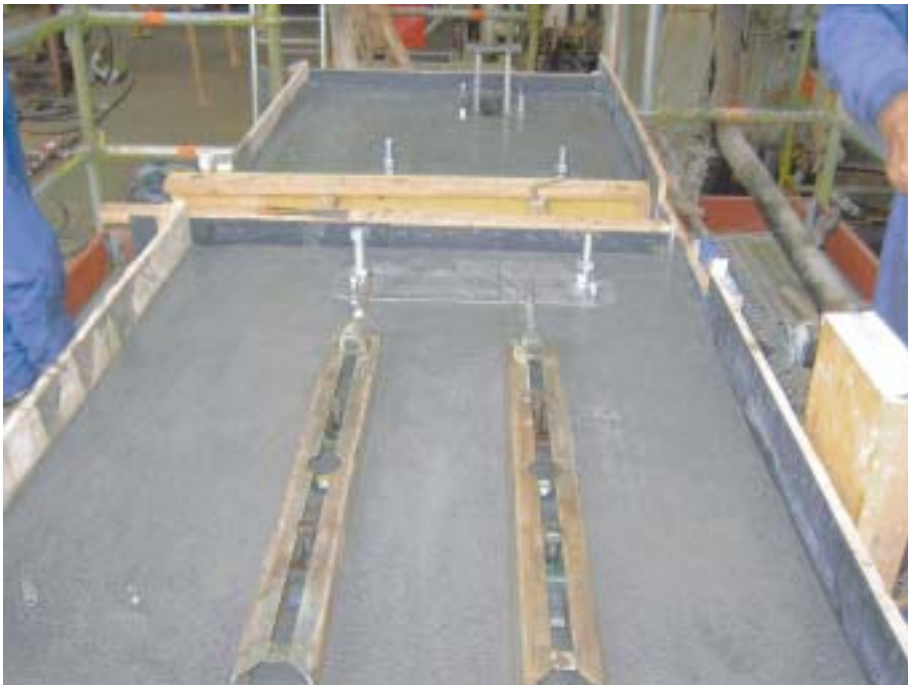
25.  
ALPHATEC 800 epoxy grout was mixed and poured to embed the crankcase soleplates, the crosshead support base, and the motor bases, and allowed to cure overnight.

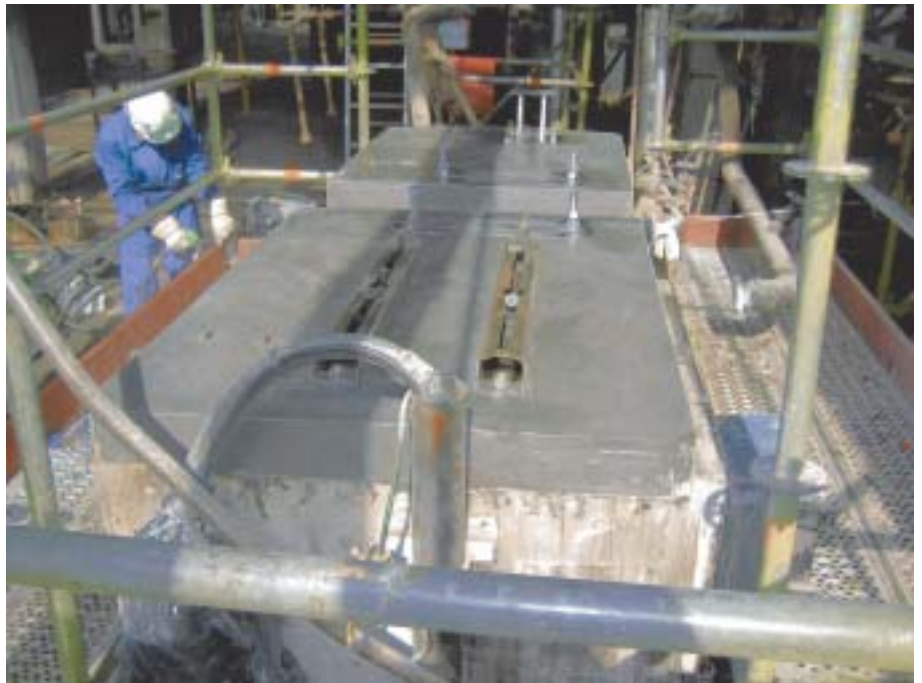
26.  
21 July 2005. Forms were removed in the morning, and sharp edges ground off.

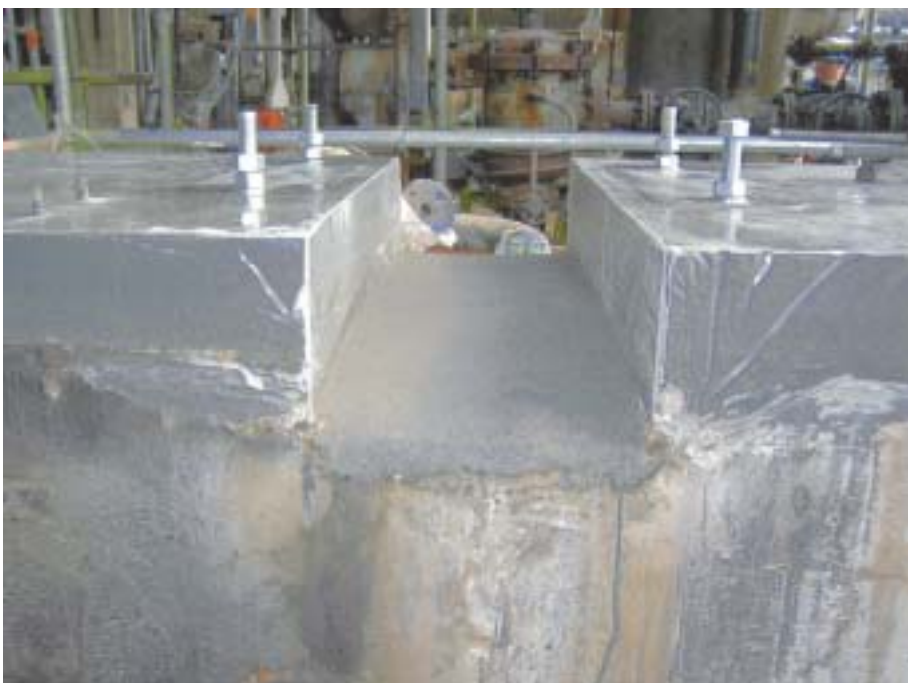
27.  
In order to protect the remaining area of bare concrete under the crankcase, it was chipped back to sound concrete, and a layer of epoxy grout poured.
