Getting the most from your machines and foundations

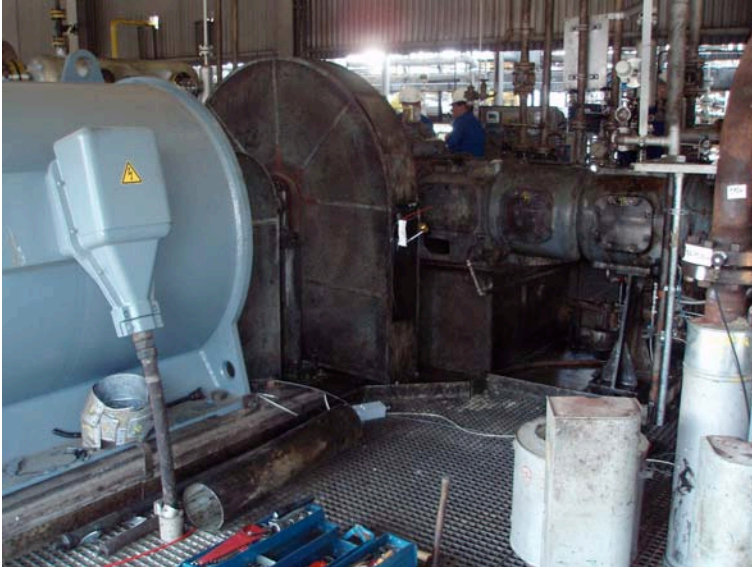
This compressor in a German refinery was suffering severe vibrations, not only in the main machine train, but also in the piping, and the surrounding structure. Alphatec Engineering was asked to look at the problem, in parallel with a specialist engineering firm who were monitoring and analyzing the vibrations. Alphatec engineers rapidly concluded that the problems stemmed almost entirely from the compressor grout, which was badly oil-soaked, and had essentially no resistance left to the anchor bolt forces.

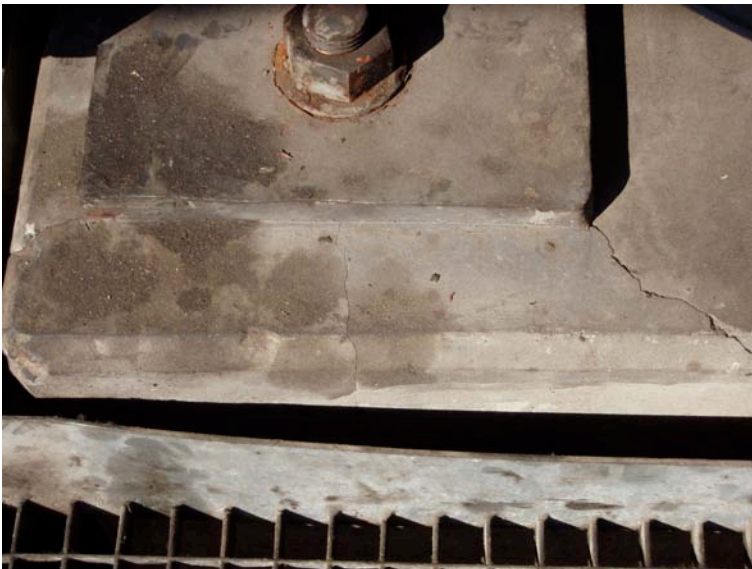
Grout supporting the motor baseplates was also suspect, with surface cracking visible, and the possibility of corrosion underneath the baseplates. The complex shape of the foundation suggested that several cold joints might exist, and the mass of the underground portion of the foundation could not be determined due to missing civil engineering drawings. All the plinths supporting the high-pressure piping were in bad shape, with some showing complete separation from the lower mat, and anchor bolts no longer in contact with the concrete. A rapid proposal and cost estimate was drawn up, and a contract awarded the day after the inspection - rather faster than expected.

The team mobilized in 3 days, and the grout removal around the motor baseplates started immediately, together with a trial core drilled through the underground mat to determine the depth of concrete, which turned out to be 900mm. Due to the extent of the compressor house mat, this meant that some 45 m³, or 100 tonnes of concrete, were available for vibration damping, once the connection between mat and plinths could be re-established.

The foundation repair was done in parallel with the grout removal. Injection holes were drilled into the foundation at strategic spots, high-strength reinforcing bar inserted, and the holes sealed with epoxy grout. ALPHATEC injection resins were pumped into the holes (through pre-placed tubing) to fill all cold joints, cracks and fissures.

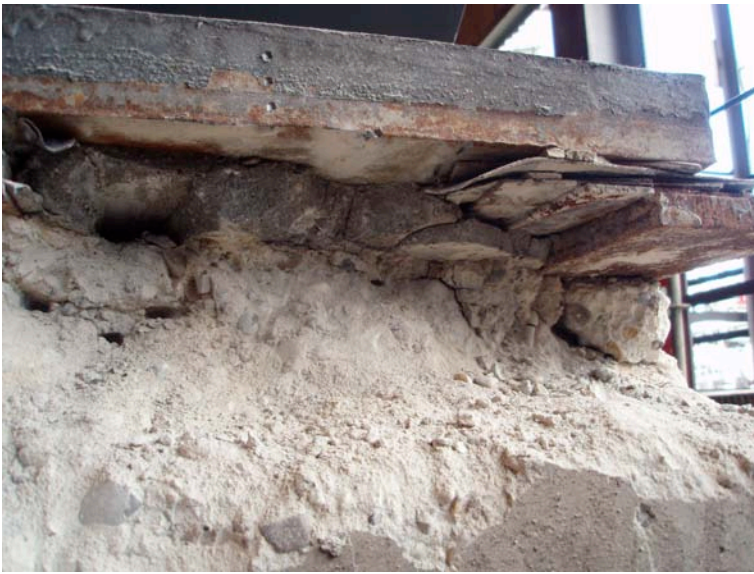
Meanwhile, the existing grout and underlying damaged concrete was removed.

Shims, packers and miscellaneous hardware were also removed, and our proprietary ALPHAPADs used to support the machine.
