WORK REPORT

FOUNDATION REPAIR
AND REGROUT
METALBOX BODYMAKER

CARNAUD METALBOX
SINGAPORE

Project: No 4 Bodymaker foundation repair & regROUT

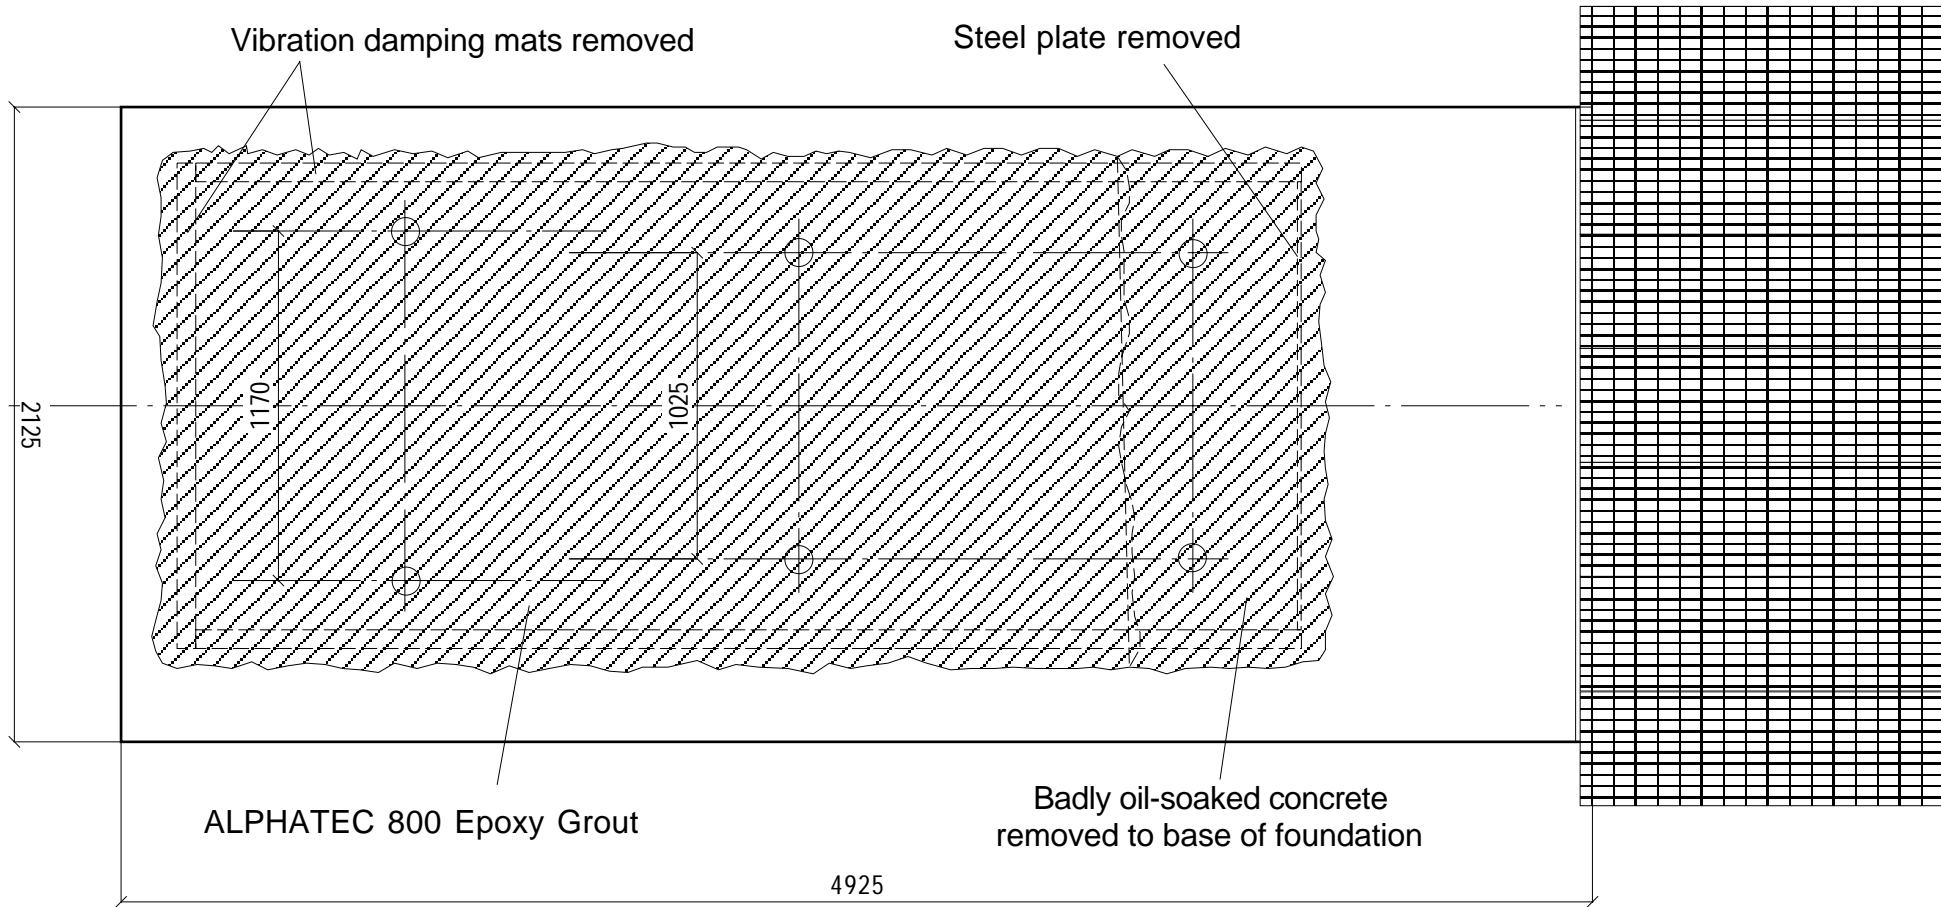
Customer:	CarnaudMetalbox, No 4 Bodymaker.			
Location:	Woodlands, Singapore			
Project:	No 4 Bodymaker foundation repair & regROUT (actual)			
Report No:	S-93-10064	Date:	94-02-08	Scale: 1:20

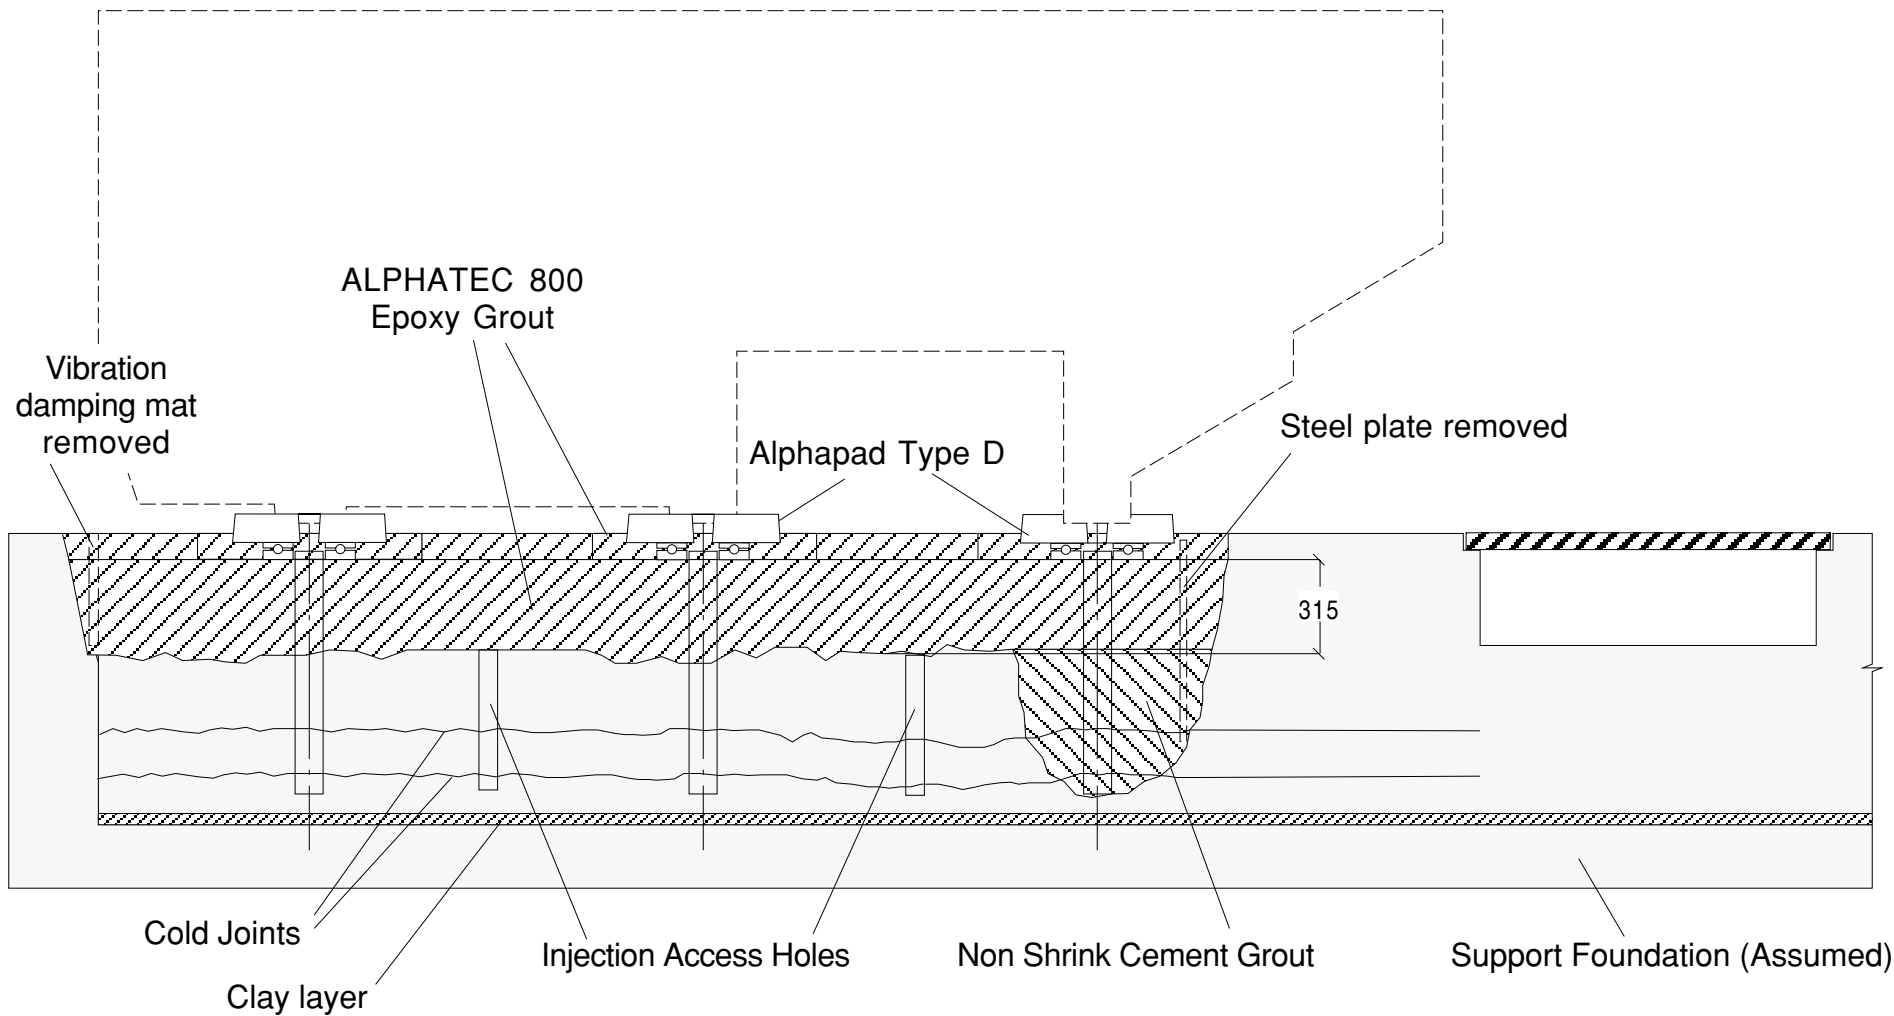
Customer:	CarnaudMetalbox Pte Ltd				
Location:	Woodlands, Singapore				
Project:	No 4 Bodymaker foundation repair & regout (actual)				
Job No:	S-93-10064	Date:	94-02-04	Scale:	1:20
